# GEOPHYSICAL SURVEY REPORT

**Geophysical survey to characterise the conditions  
of North Promenade, Barmouth**

Job reference: 7328

Date: February 2021

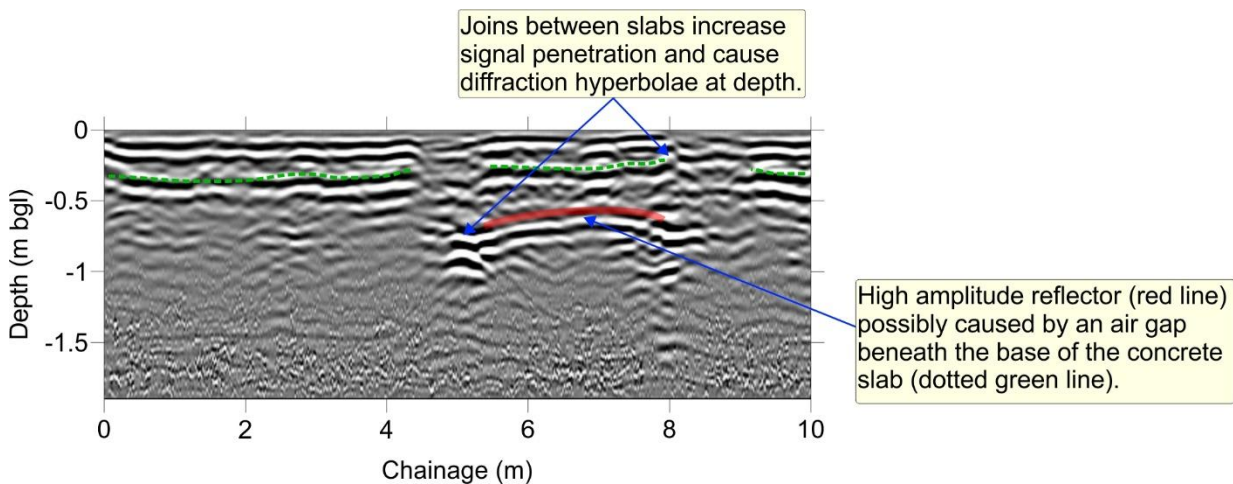
**1) High amplitude reflectors**, which may also dip or ‘sag’ along their length. High amplitude reflectors may be caused by laterally extensive air gaps between the concrete slab and the underlying fill. Dipping or sagging reflectors may suggest that a horizon is no longer supported due to loss of material below and may represent subsidence. See the example data in Plate 4 below.

**Plate 4:** Example GPR data of a high amplitude reflector which may be indicative of voiding.

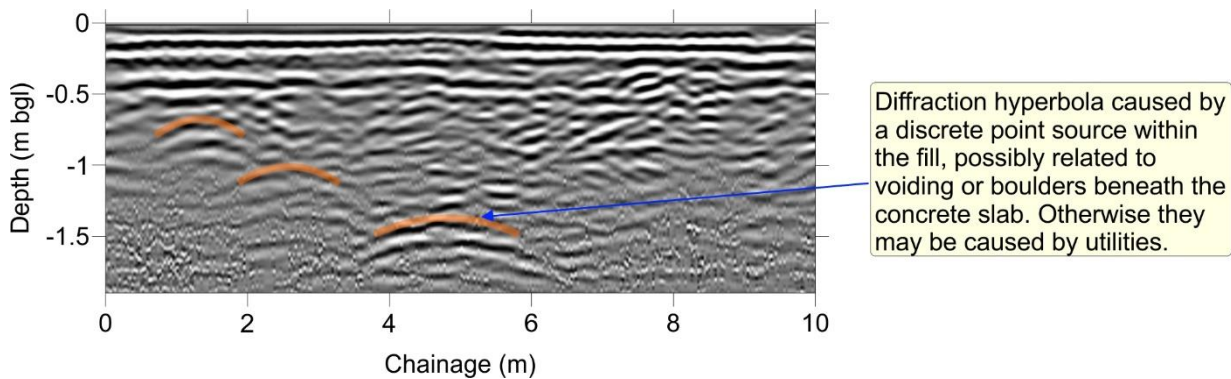
**2) Diffraction hyperbolae** caused by a ‘point source’, a short feature of significantly different dielectric properties. For example, a spherical void; however, these are also caused by other discrete features such as boulders or utilities. See the example in Plate 5.

**Plate 5:** Example GPR data of an isolated diffraction hyperbola which may be indicative of a void. Example data extracted from the 500 MHz antenna data set.

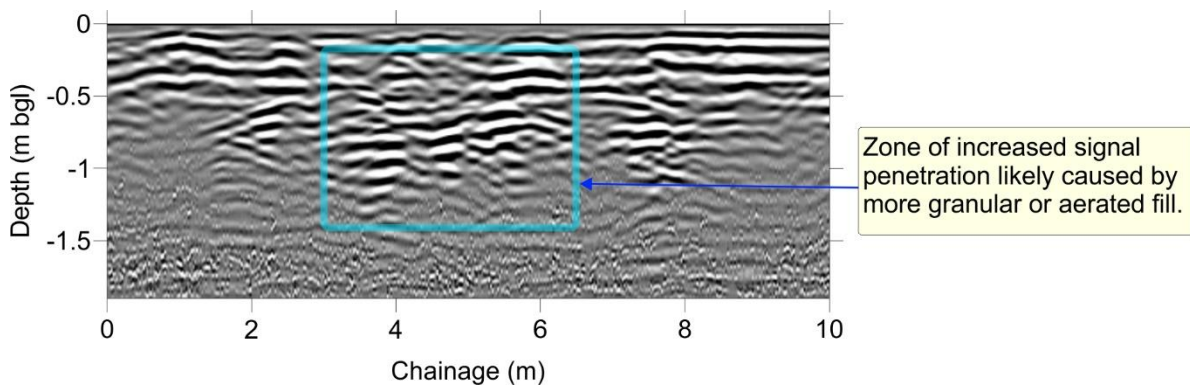
**3) Zones of increased signal penetration,** areas where a large amount of the GPR signal is reflected. This is caused by granular or aerated fill and potentially voiding. See the example below in Plate 6. At some locations regularly spaced zones of increased signal penetration are observed and relate to the presence of joints between slabs, the presence of isolated zones of high-amplitude response beneath the joints may be indicative of localised voiding associated with them.

**Plate 6:** Example GPR data showing characteristic data from the site. Example data extracted from the 500 MHz antenna data set.

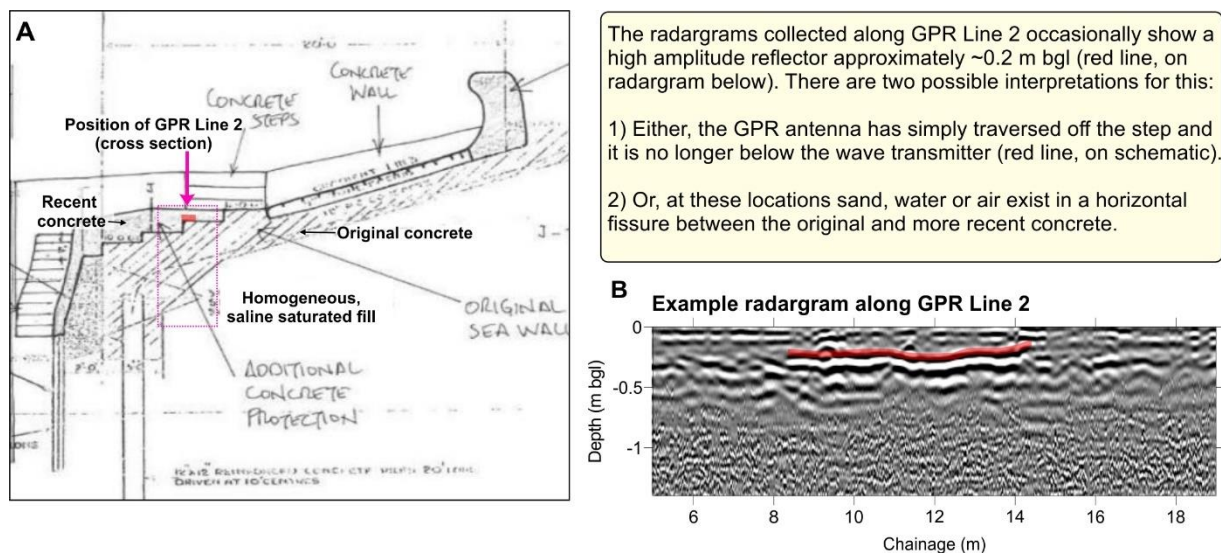
The radargrams collected along GPR Line 2 inconsistently display a high amplitude reflector approximately ~0.2 to ~0.3 m bgl (an example is highlighted in red on Plate 8). There are two possible interpretations for this:

- 1) The line of GPR 2 is located close to the edge of a step and occasionally crosses from an upper to a lower step.
- 2) Or, at these locations, voiding/washout is present between different ages of concrete, creating a high amplitude reflector.

**Plate 8. A)** Historical drawing provided by the Client showing the current construction of the sea defence with respect to the position of GPR Line 2. **B)** Example data acquired along GPR Line 2.

Radargrams 278 and 280 show the intermittent character of the shallow reflector, and it is recommended that this is investigated intrusively to determine if this feature is caused by horizontal delamination along with the different phases of construction and refurbishment or is an artefact of the acquisition over the buried step.

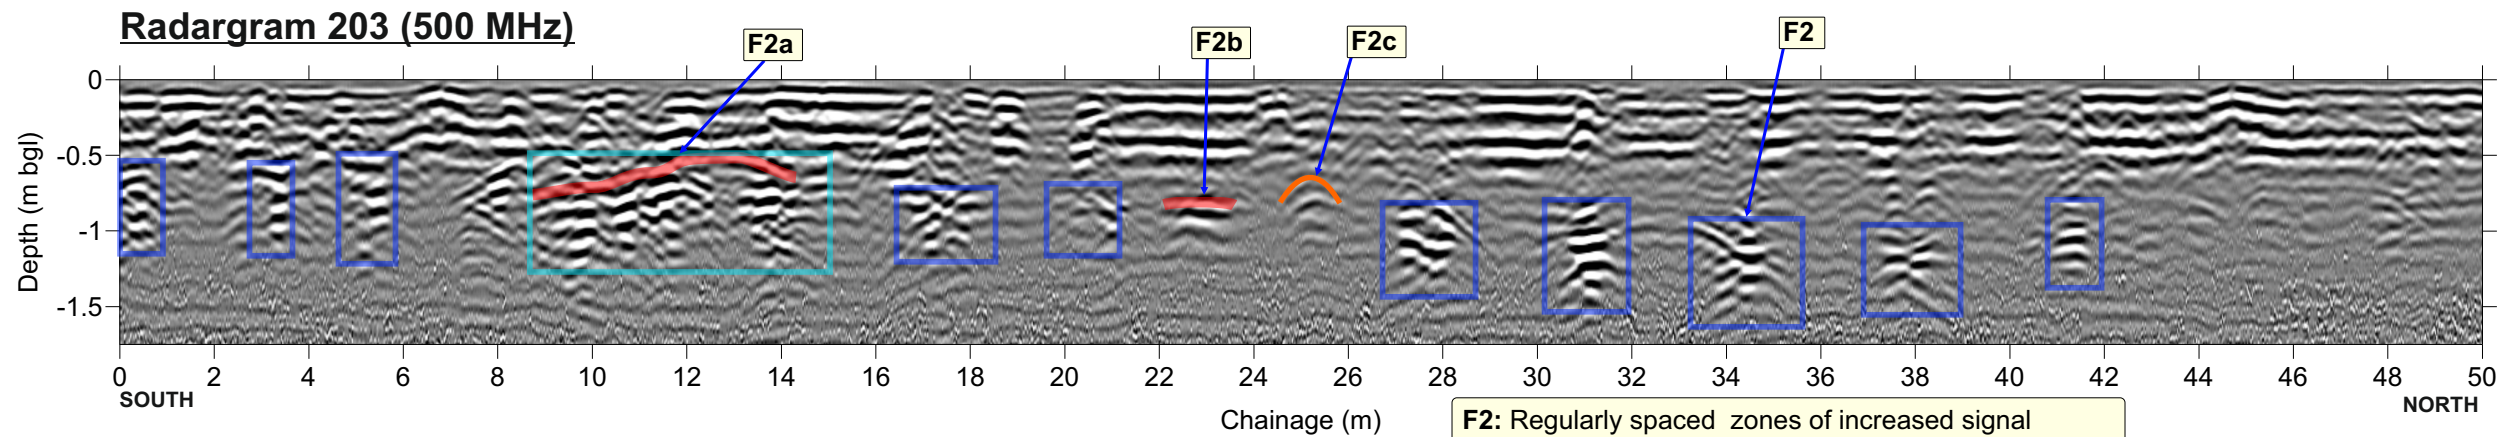
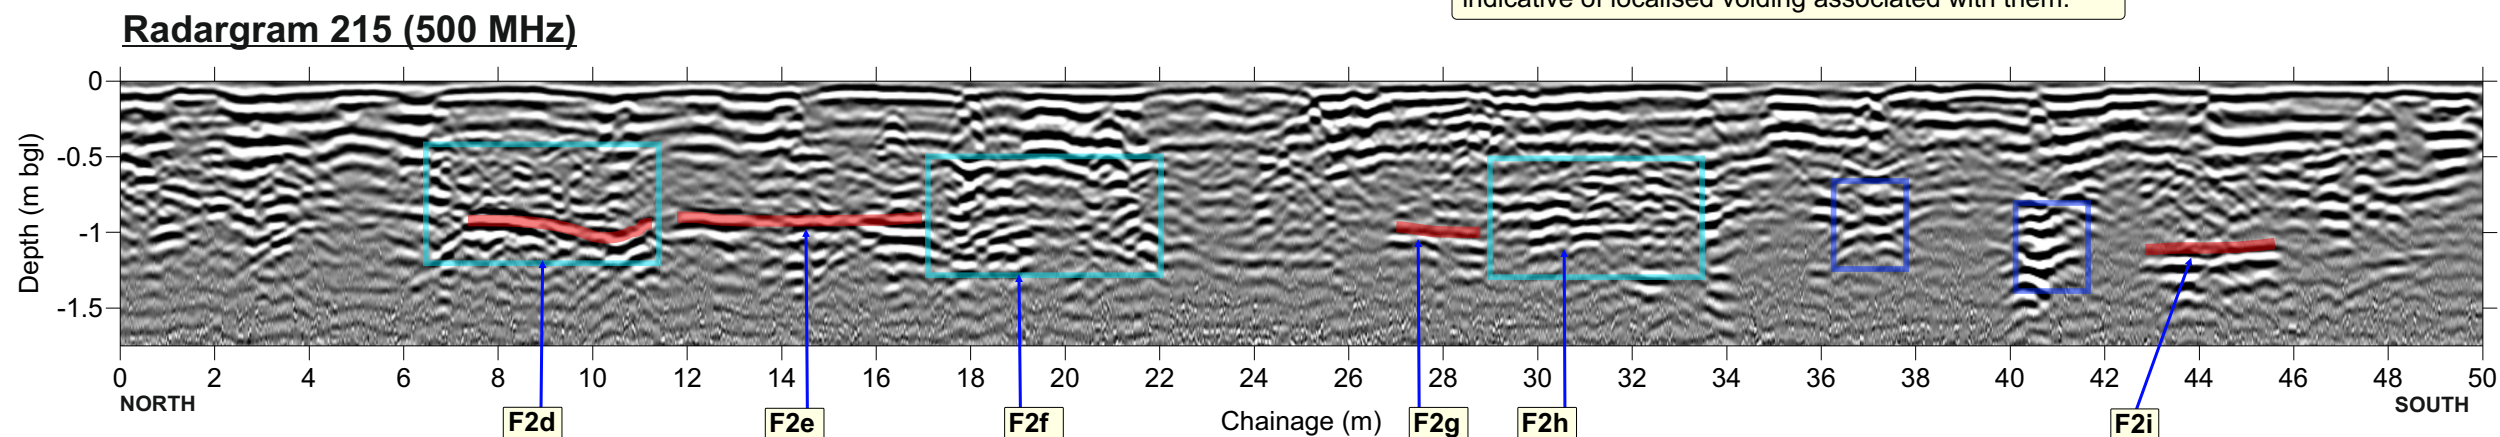
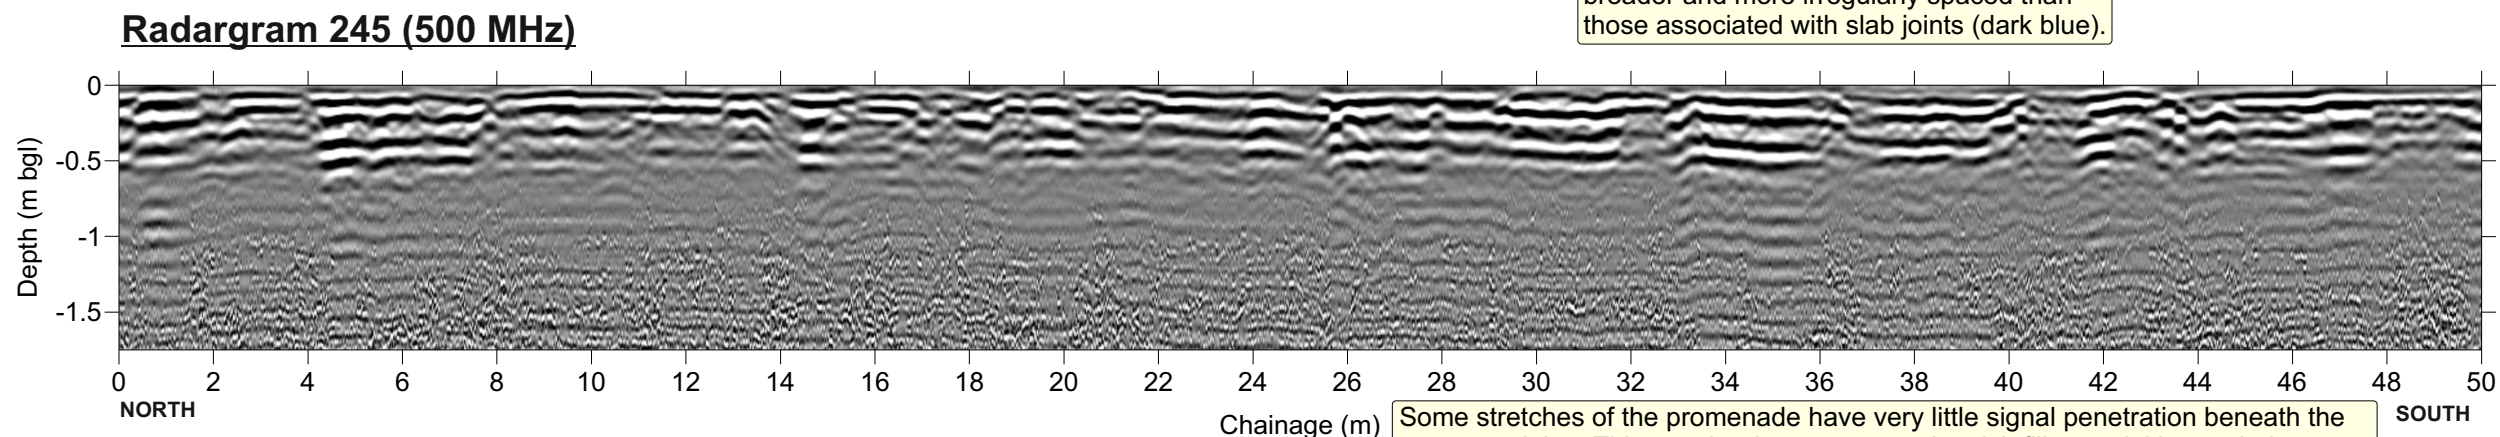
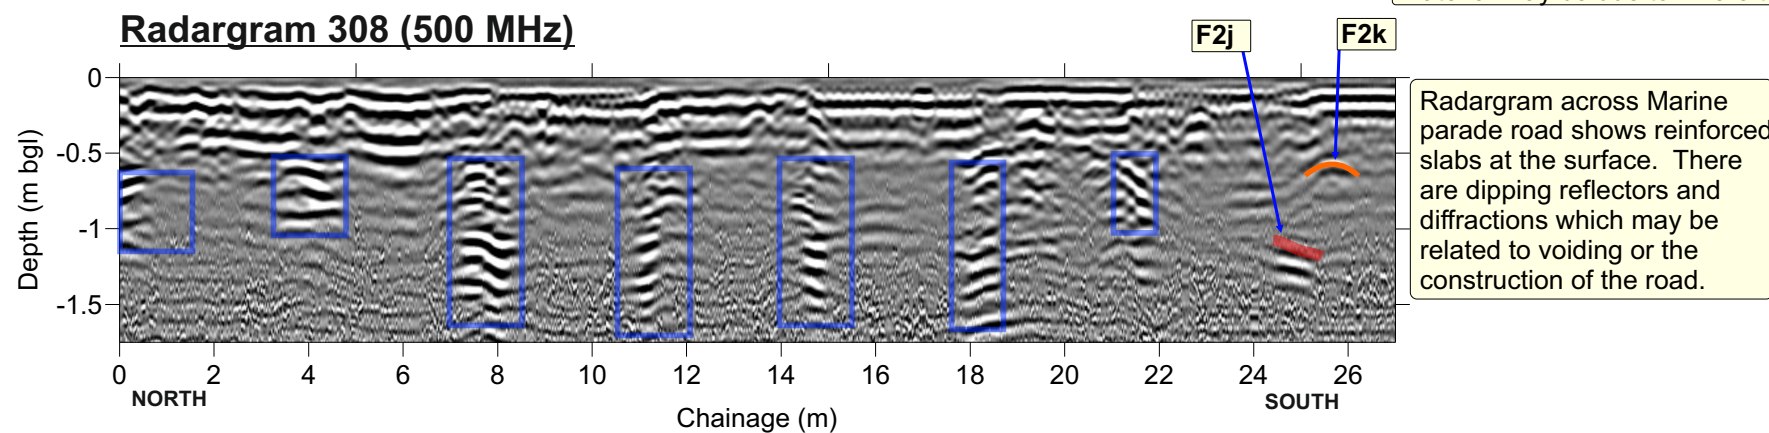
**FIGURE 2**

Radargram 203 was acquired along the footpath in the south of the survey area, where the data has a good signal penetration to 1.5 m bgl. Regularly spaced zones of increased signal penetration (shown in dark blue) relate to the presence of joints between slabs, the presence of isolated zones of high-amplitude response beneath the joints may be indicative of localised voiding associated with them, one such feature has been noted as **F2**. The locations of such features are shown on Figure 4. Laterally continuous, high amplitude reflectors are occasionally also observed (**F2a**). High amplitude reflectors are also observed away from the broader zones of increased signal penetration, e.g., **F2b**. An isolated diffraction is also observable and may be caused by a void, boulder or utility (**F2c**).

Radargram 215 was also acquired along the footpath in the south of the survey area. This profile shows several broad areas of increased signal penetration and multiple high amplitude reflectors at approximately 1 m bgl (**F2d to i**).

Example radargram 245 shows significant signal attenuation beneath the concrete slab. This is thought likely to be caused by increase conductivity of the fill material beneath the slabs and may reflect an increase in the clay content of the fill material (this location coincides with the presence of a historical stream) or fill material saturated by saline water.

Radargram 308 shows an example of data acquired across Marine Parade Road. The road appears to be underlain by reinforced slabs (as indicated by the numerous shallow diffraction hyperbolae) and some of the voiding-related features discussed previously are observed (**F2j and k**). It should be noted that the signal penetration increases with distance away from the

**F2a, b, e,g,i and j:** High amplitude reflectors possibly caused by air gaps in the made ground beneath the concrete slabs. In some cases these are coincident with zones of increased signal penetration.

**F2c and k:** Diffraction hyperbolae potentially caused by small isolated voids in the subsurface.

**F2d, f, and h:** Zones of increased signal penetration possibly caused by more granular, aerated fill. In some areas they are coincident with high amplitude reflectors.

To better interpret the data, an intrusive investigation of all examples of the identified features is highly recommended. The acquisition of cores will allow calibration of the results of the geophysical survey, after which the interpretations within this report can be refined.

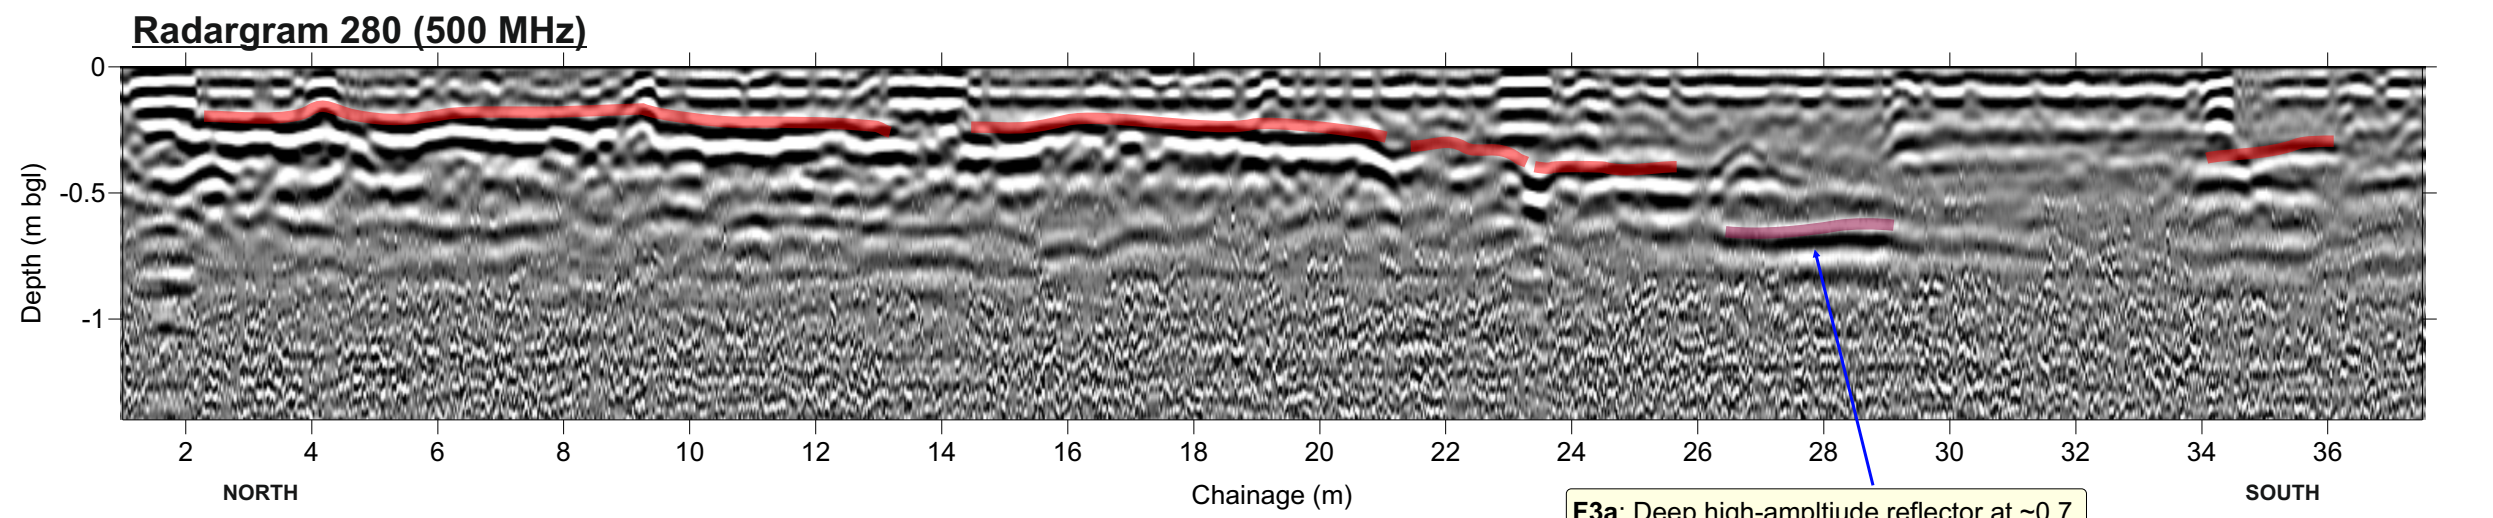
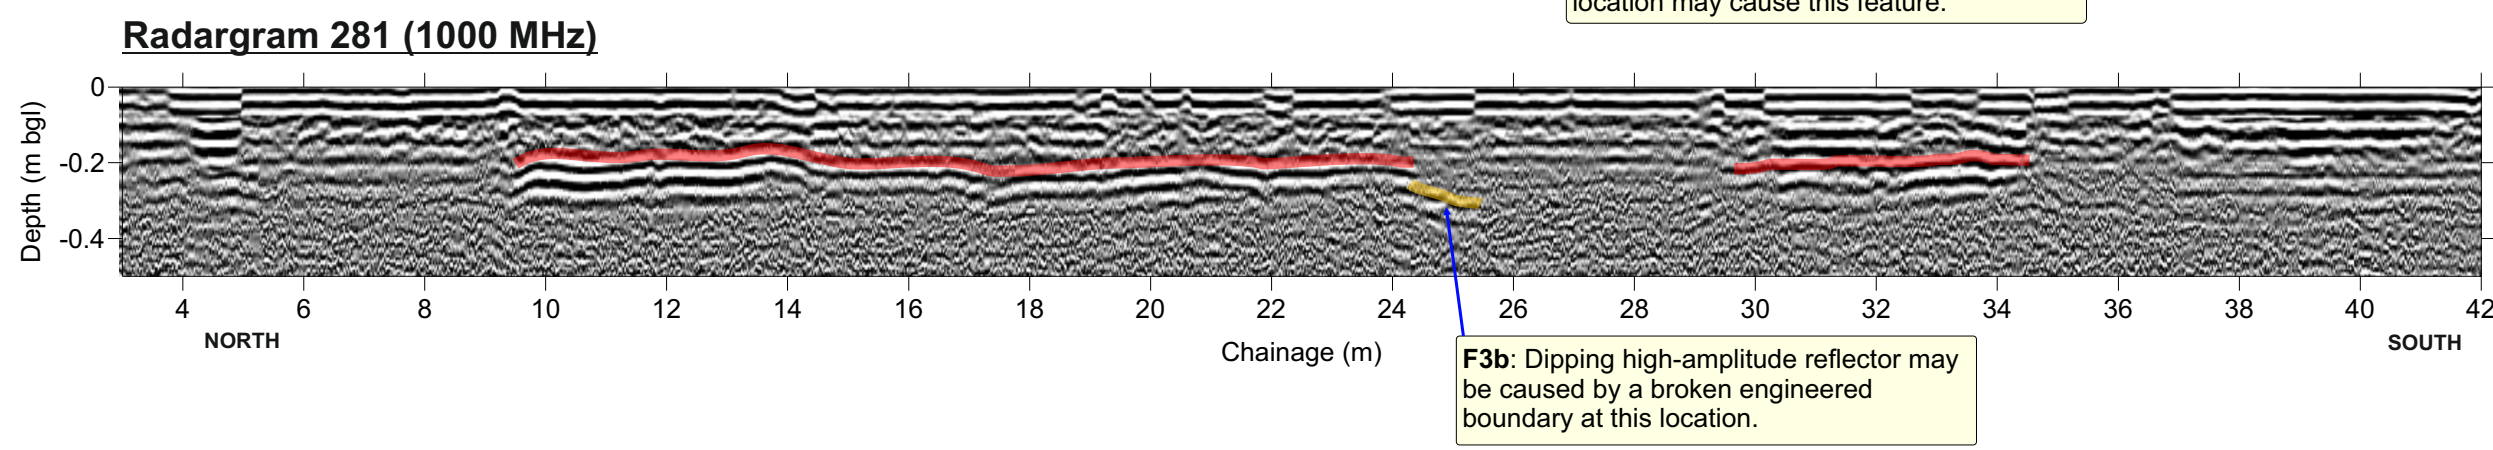
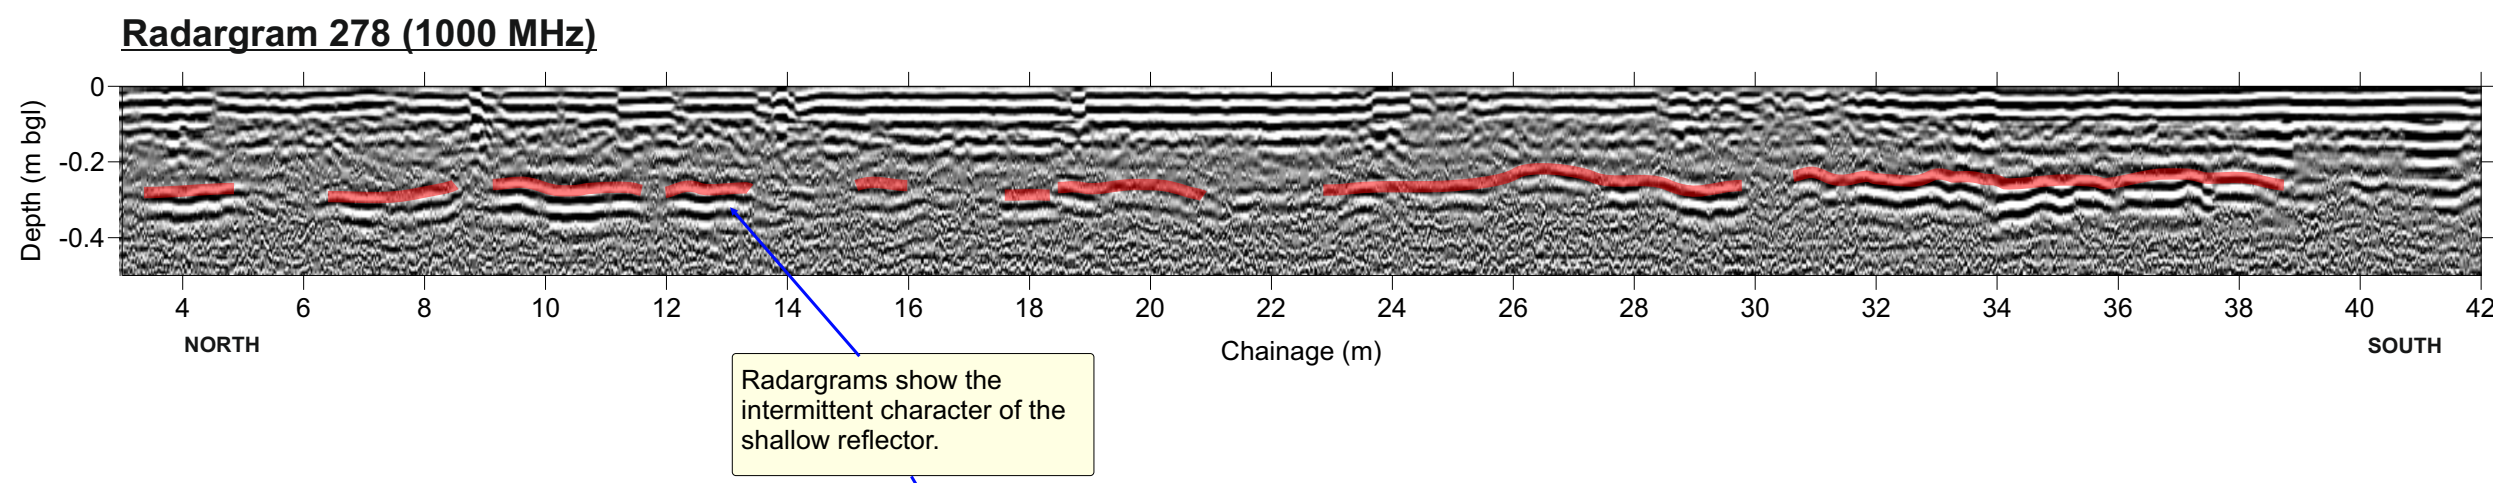
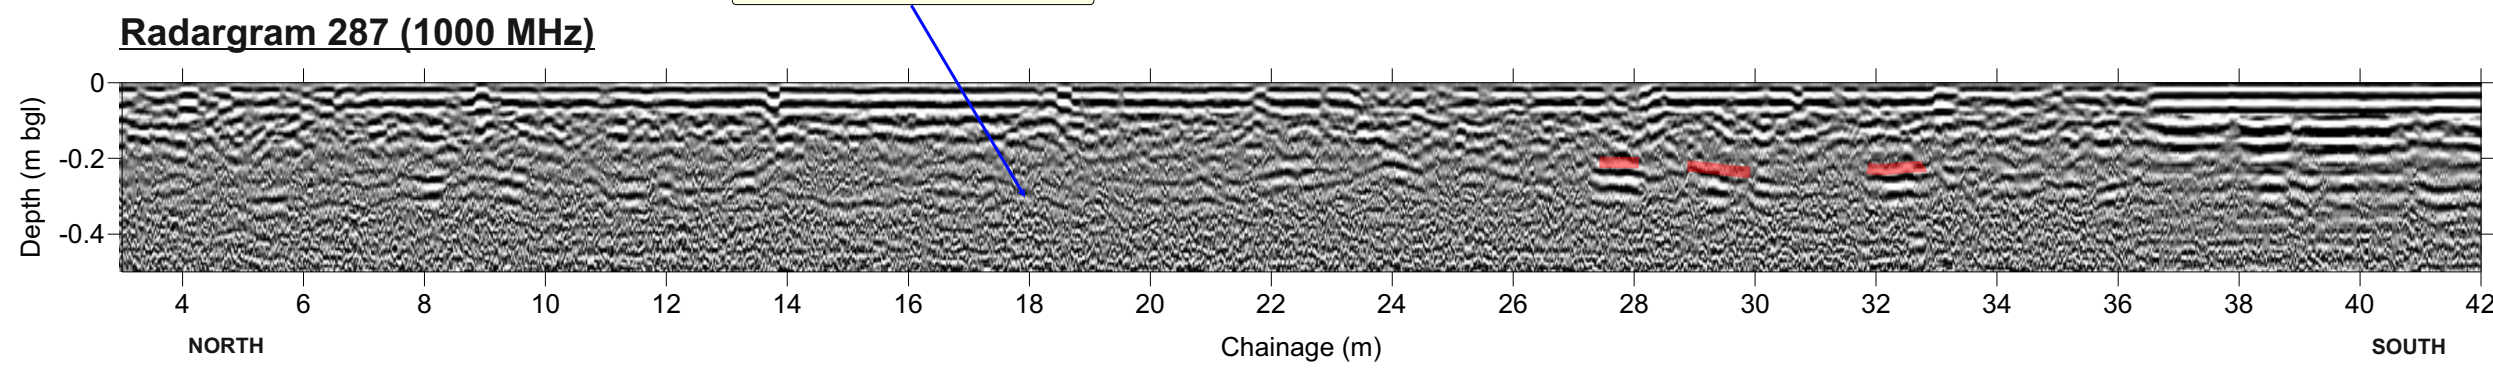
**FIGURE 3**

Radargram 280 shows an example of data acquired by the 500 MHz antenna. The shallow intermittent reflector discussed previously is highlighted in red. However, a short deeper reflector is also observed at ~0.7 m bgl and highlighted in purple (**F3a**). At this depth, it is thought that the base of the original concrete steps overlies the saline saturated fill, where a high amplitude reflector is observed, there may be an air gap between the base of the concrete and the fill. Where this deeper reflector is observed it has been digitised and shown in Figure 4.

Feature **F3b** is a short, dipping, high-amplitude reflector. This feature occurs along what may indicate the presence of a historical surface (step), break or inclination in this surface may indicate damage to the structure.

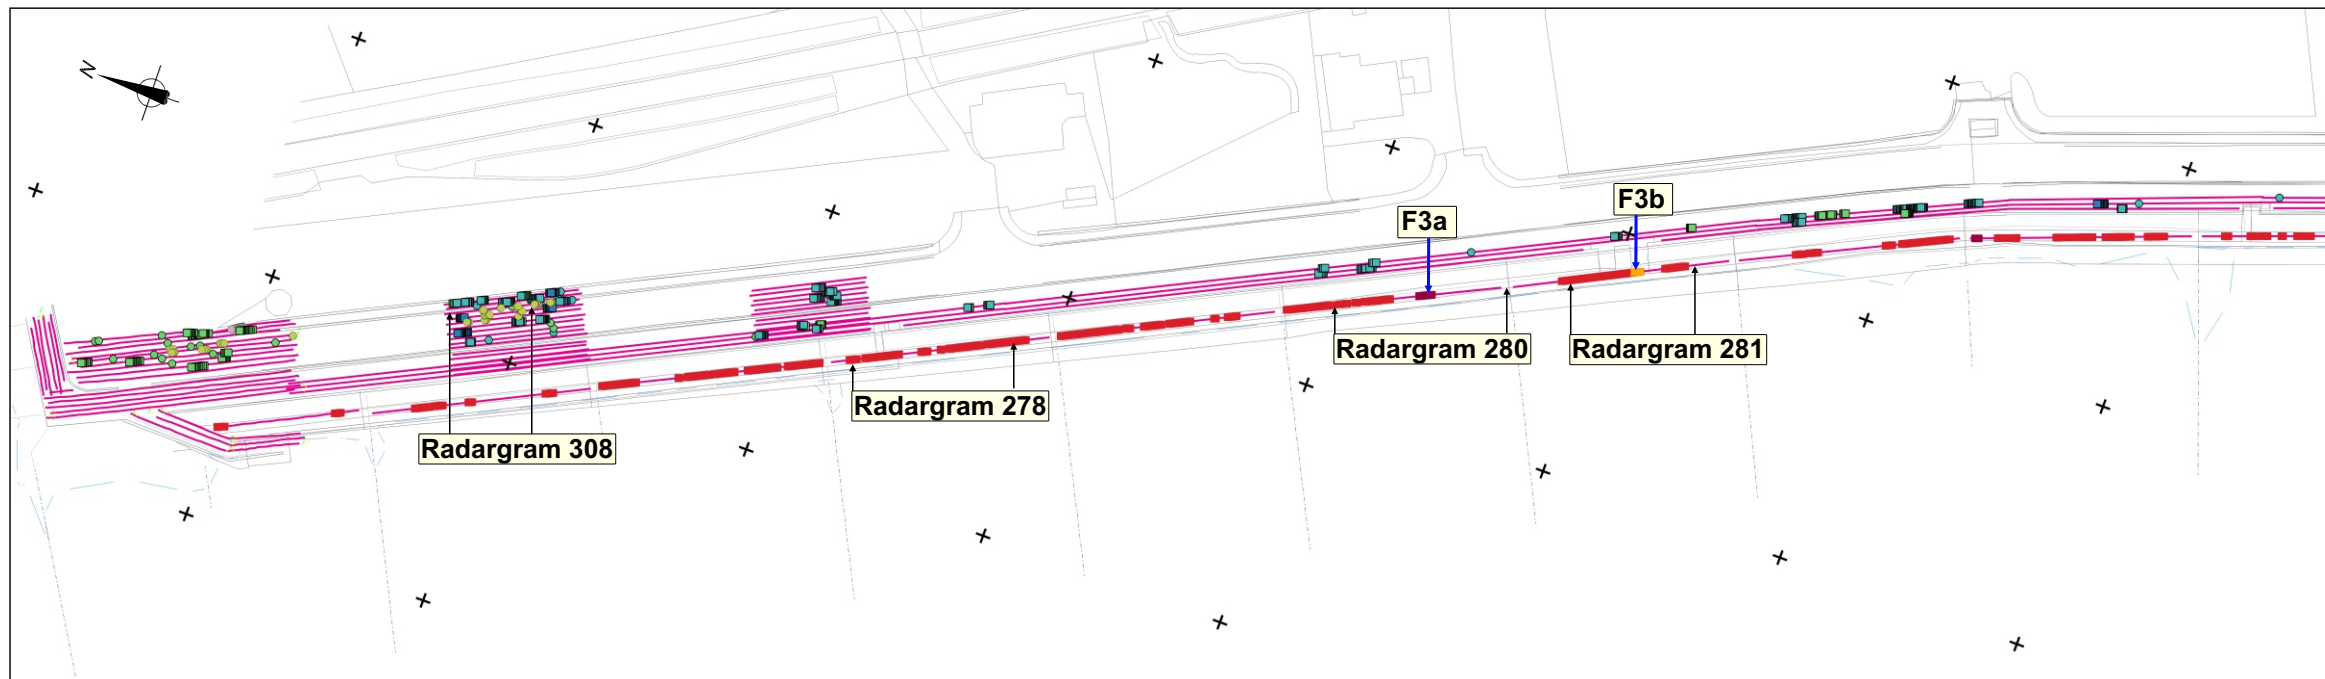
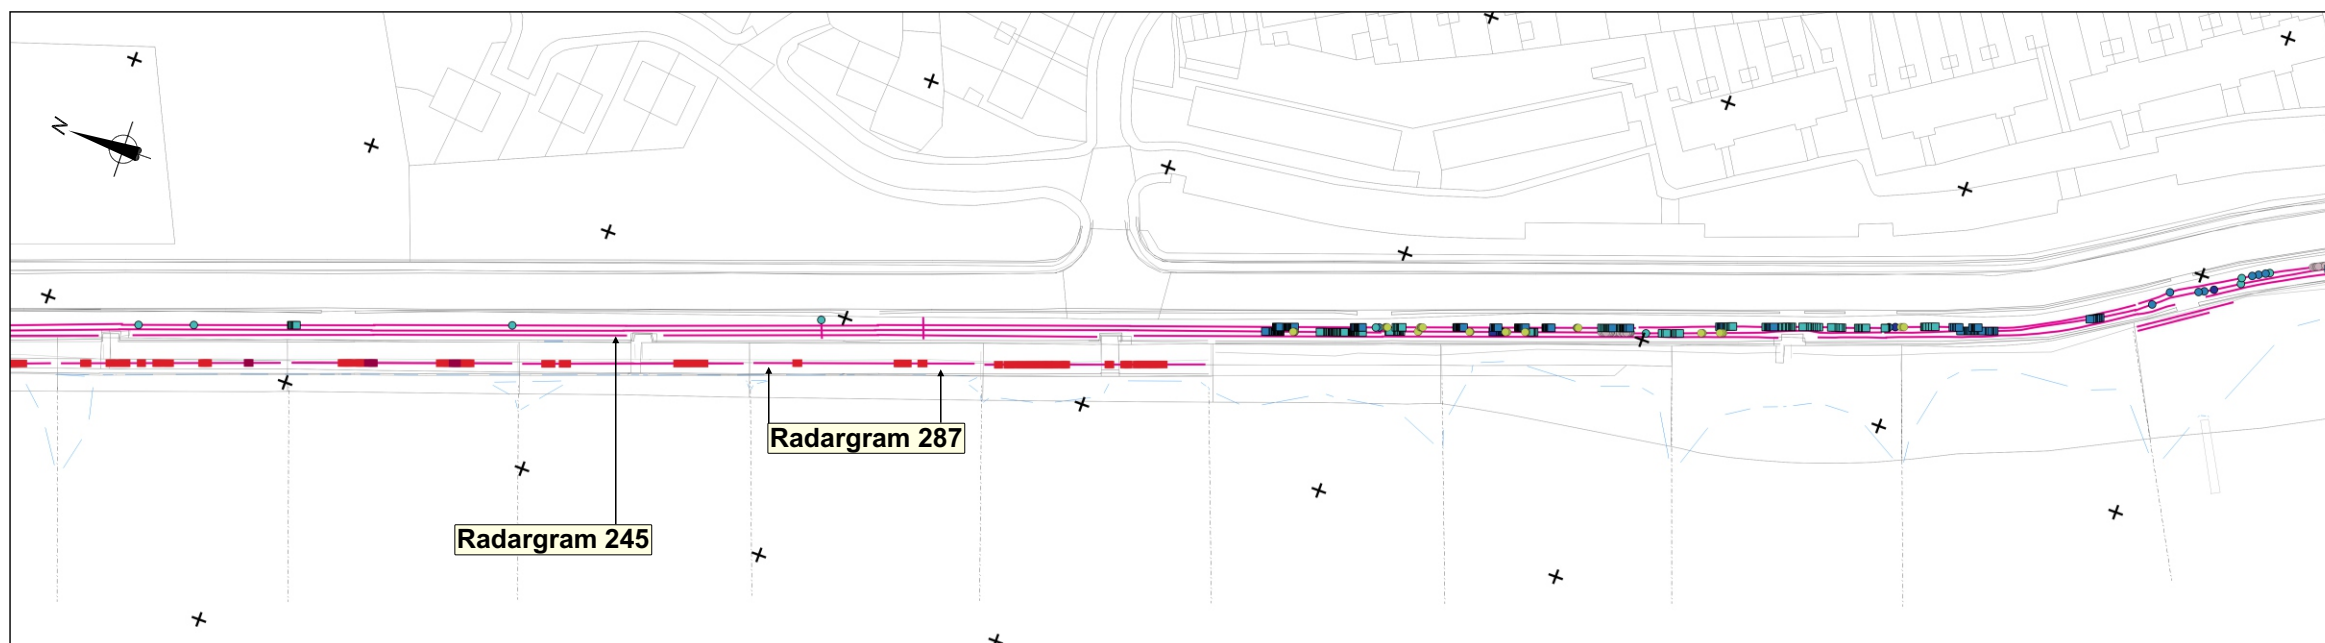
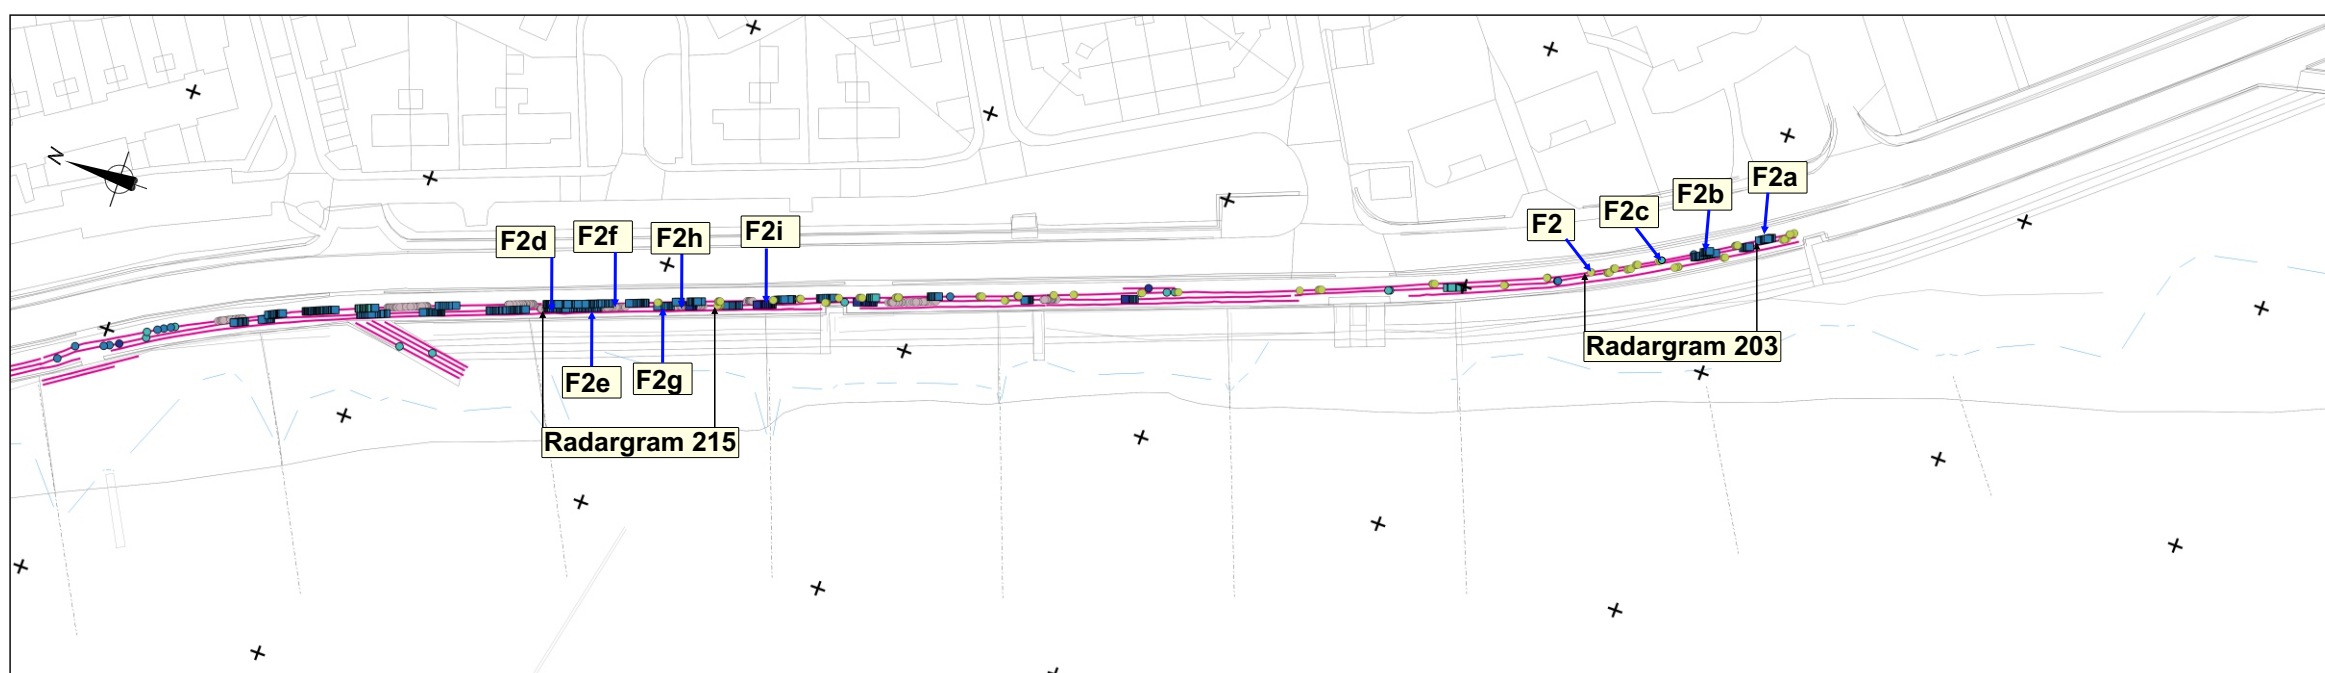
**Figure 4** presents the extents and locations and approximate depths of the numerous GPR response types, which may be related to potential voiding across the survey area. It is recommended that representative areas of highlighted GPR response are relocated on-site using a survey-grade RTK GPS and investigated intrusively. Figure 4 has also been provided in digital CAD format (7328\_Barmouth\_feature\_locations.DXF) in OSGB coordinates.
