| Project title | Barmouth North Promenade | Job number |
| Subject | Existing Coastal Defence Structures Review | |

# File Note

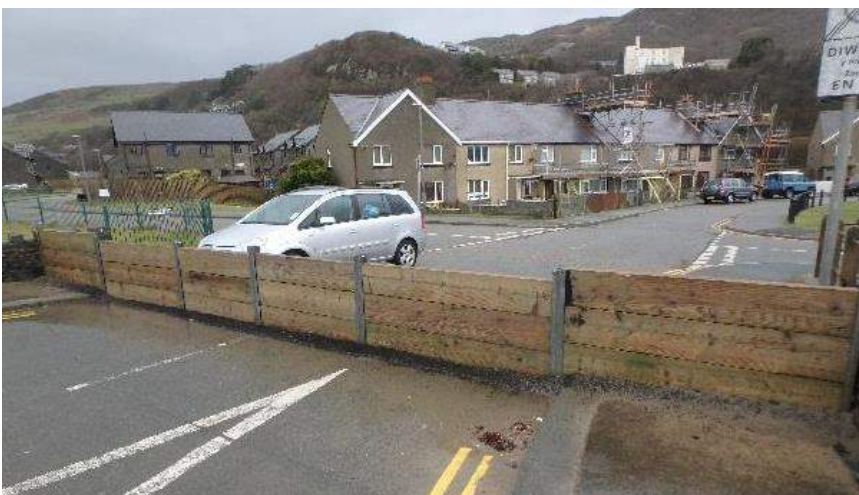
Figure 7: Demountable stop logs were seen to be deployed (2018 MML report)

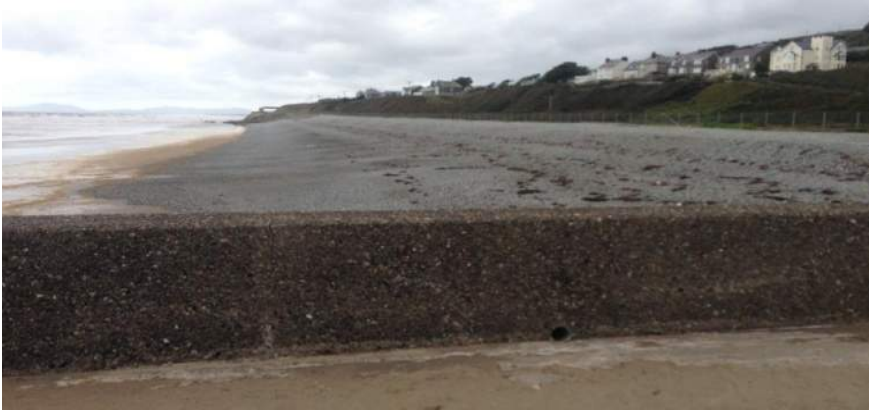
Figure 8: Shingle berm providing protection to the railway line at the north of the promenade (Arup, 2018)

*“The shingle berm in front of the railway line north of the promenade is in good condition. Given the good condition of this shingle embankment, there is the potential that this may be proactively managed.”*

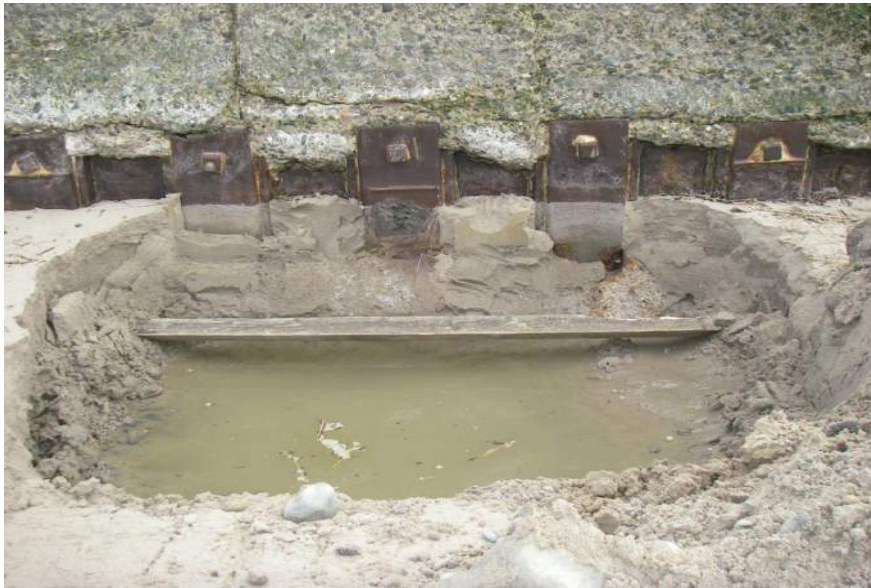
Figure 12: Sheet pile trial hole

- Exposed sheet pile at the northernmost 200m, with signs of beach drawdown. Evidence of loss of sheet pile section and severe abrasion of concrete encasement was found at some locations (between chainage 0050-0100m approximately).

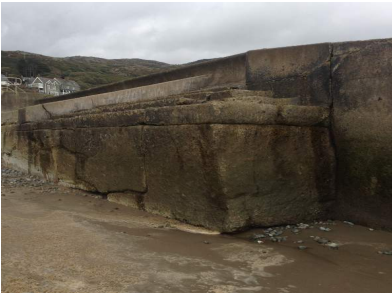
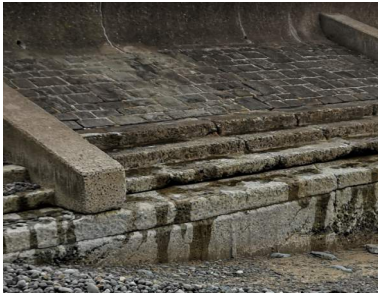
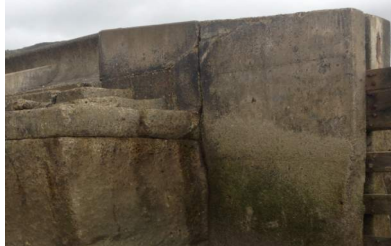
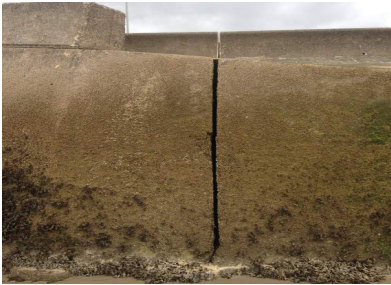
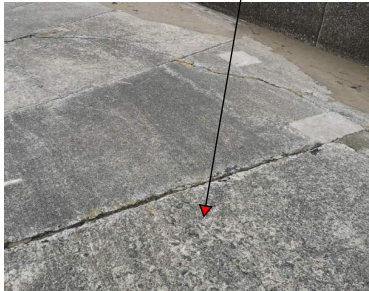
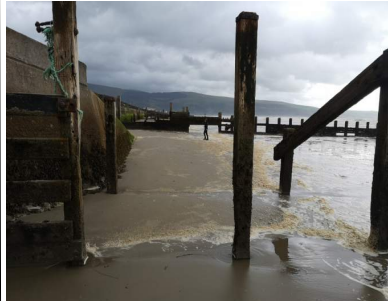
| 0000-0030m | | | | | | |
|---|---|---|---|---|---|---|
| Notes | 2014: General photo of the north facing extent of the promenade.<br>2018: A shingle embankment provides flood and erosion protection to the railway line.<br>2018 (Arup): Loss of beach material has reached the base of the structure. Risk of undermining. | 2014: Abraded cold joint at the northern extent of the promenade.<br>2018 (Arup): This seems to be in similar condition in 2018. | 2014: Vertical joint suggesting slight seaward movement at the northern side of the promenade.<br>2018 (Arup): The joint aperture does not show additional movement. | 2018 (Arup): Open joints suggest displacements, maybe due to settlement. | 2018 (Arup): Fill material loss through one of the promenade slab joints. | 2014, 2018 review and 2018 (Arup): Some groynes at the northern end of the beach are in extremely poor condition, in some cases the majority of boards are missing and the existing piles are rendered useless due to loss of section through the effect of shingle abrasion. |

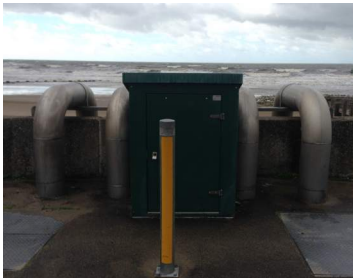
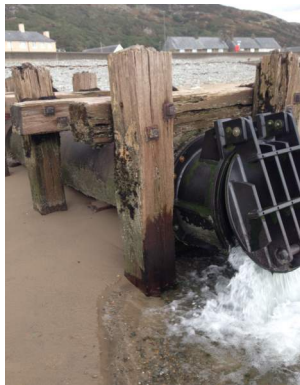
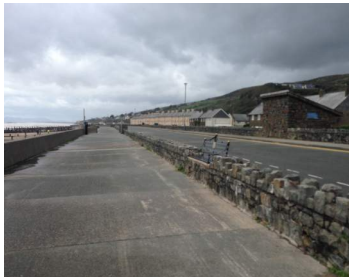
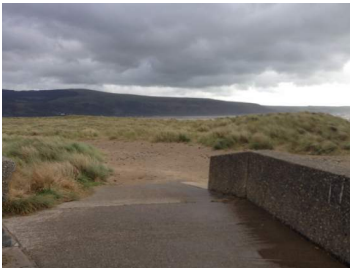
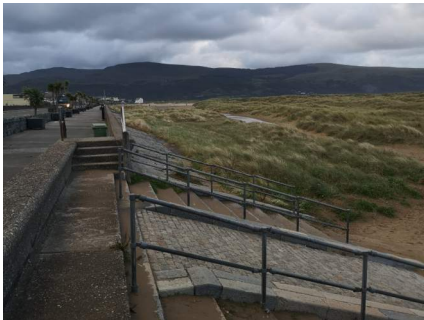
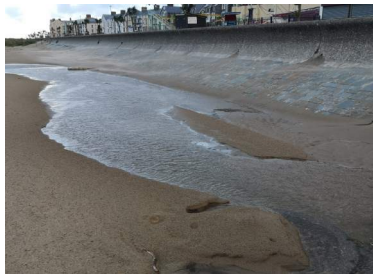
| | | 0840-1900m | | | Beyond extents of study | |
|---|---|---|---|---|---|---|
| Notes | 2014: During storm events flood waters were actively pumped from the road's drainage system over the sea defences<br>2018 (Arup): The system is considered to be in good condition structurally, except oxidation damage on the seaward face | 2018 (Arup): Outfall point of surface waters. Flap valve considered to be in fair condition and working as expected. | 2018 & 2018 (Arup) : Secondary wall has been retrofitted with benches | 2018 & 2018 (Arup): A significant dune system has formed to the southern extents of the frontage, protecting the southern end of the promenade from wave action. | 2018 & 2018 (Arup): Concrete wave wall on the southern of the promenade is in good condition | |

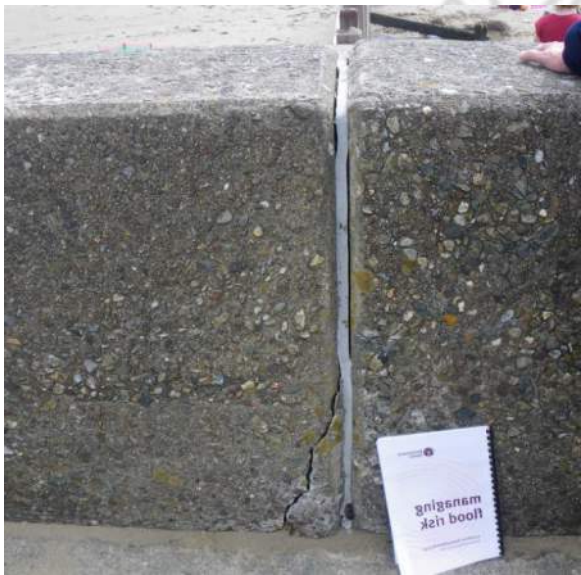
*Back of parapet, 5th groyne from north,  
weathering of joint edge*

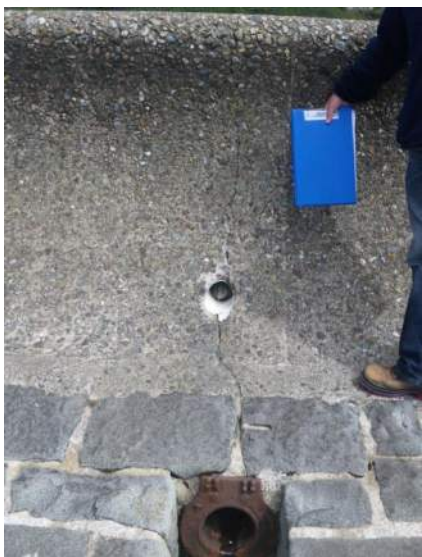
*Example of vertical crack in parapet*

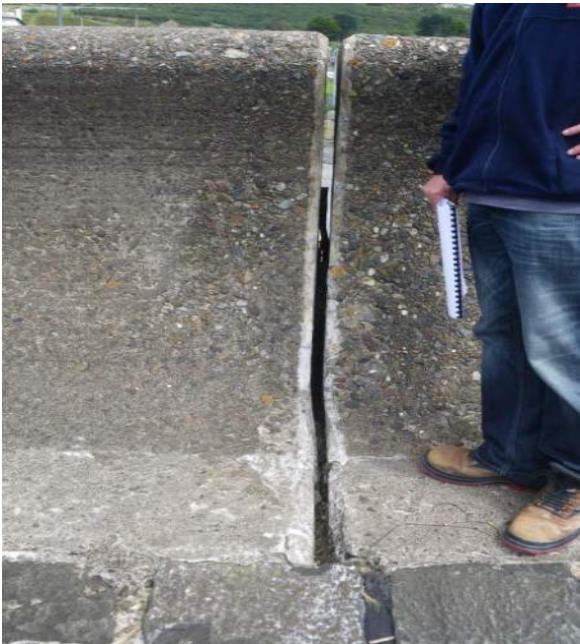
*Parapet joint sealant missing - near north slipway*

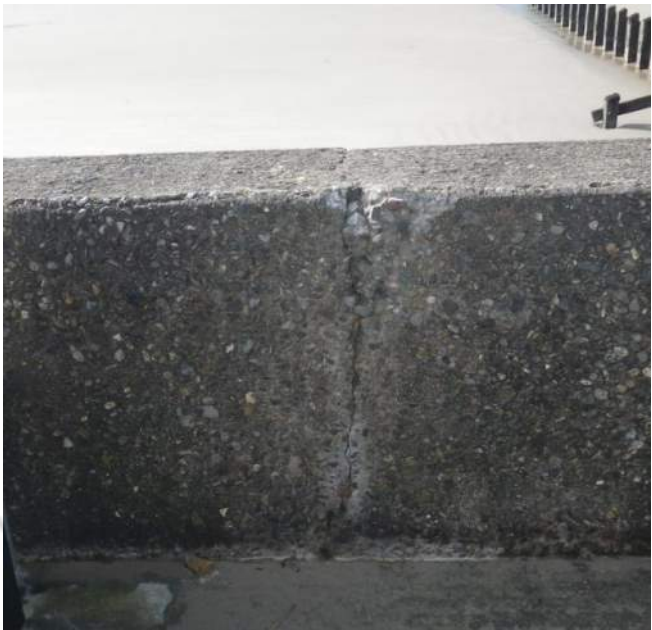
*Crack in back of parapet opposite  
end of Tai'r Heli*

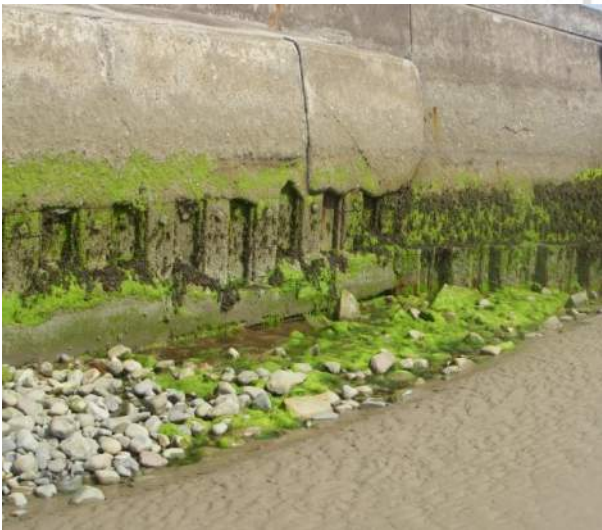
*Base of concrete haunch exposed*

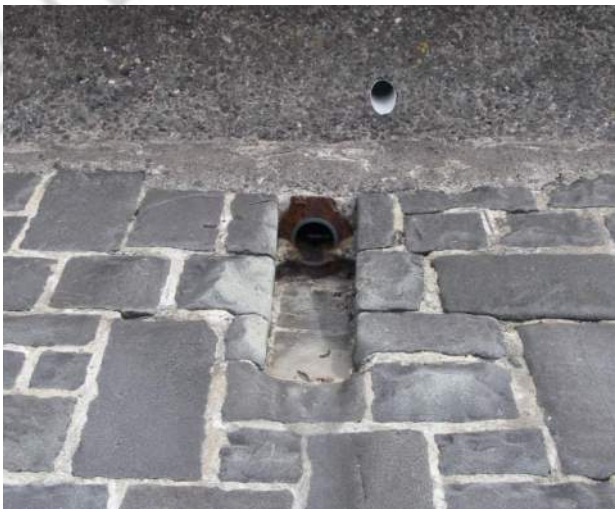
*Flap valves missing*

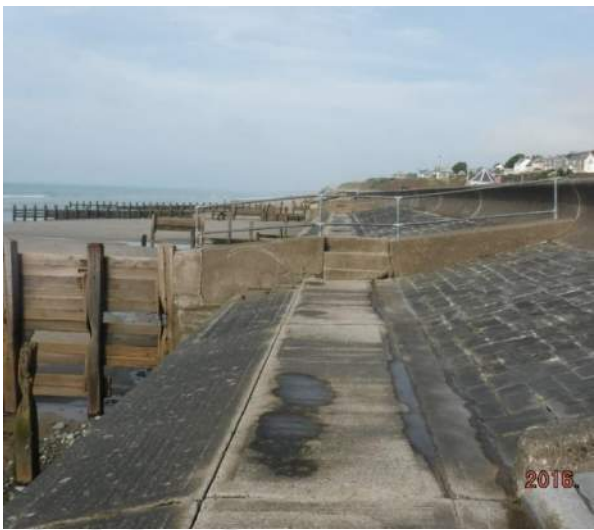
Safety railings at Groyne 26 need removing
