# Barmouth North Promenade

## Coastal Processes

February 2019

| Document History and Authorisation | | |
|---|---|---|
| <b>Document ref</b> | R.3096 | |

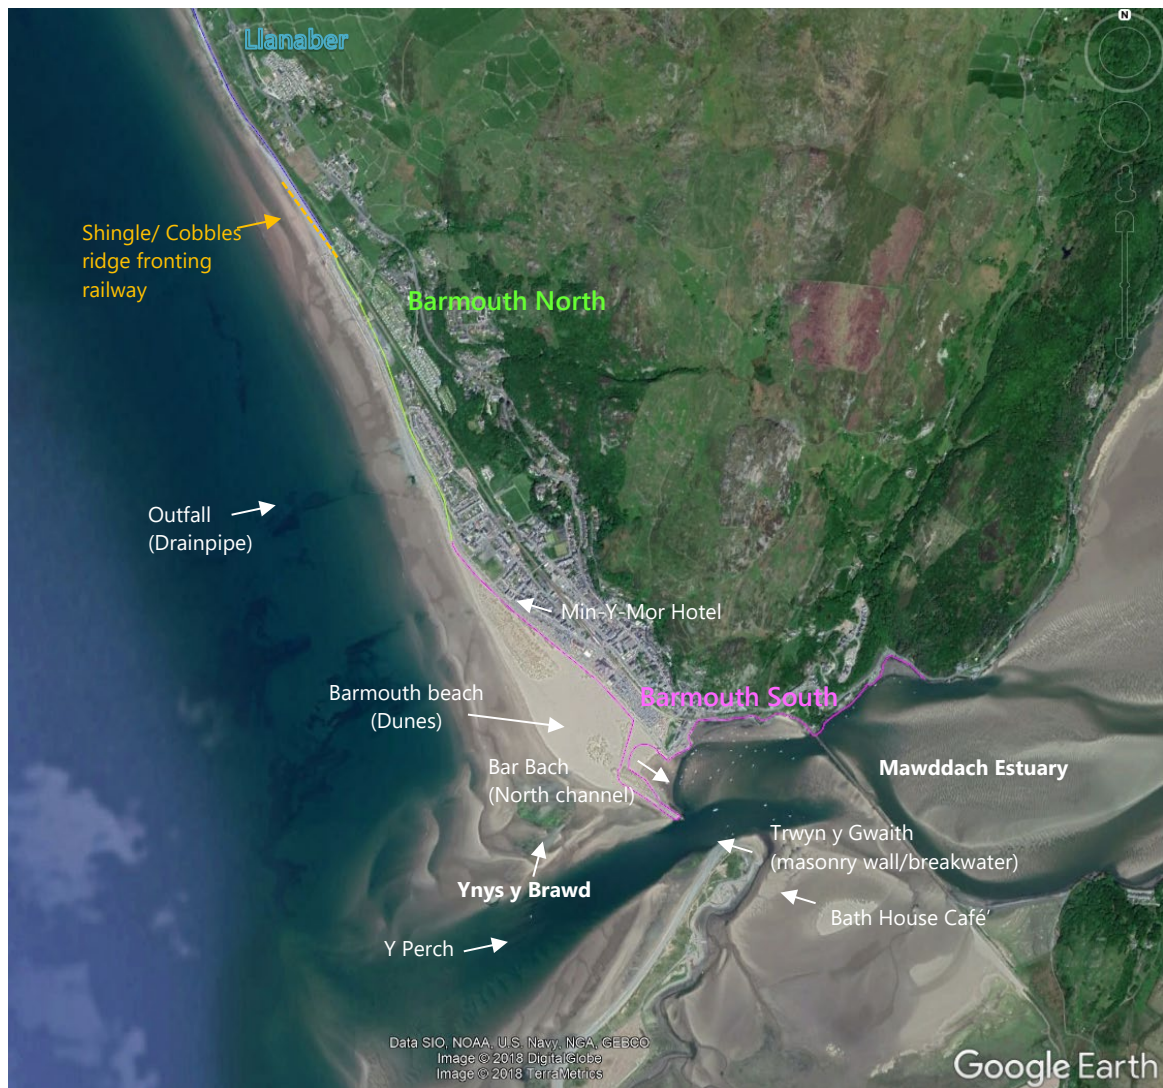
**Figure 1.** Location of Barmouth North Promenade with historical names and sediment regions (sand and shingle) and Shoreline Management Plan (SMP2) Policy units: **Llanaber** (11.16), **Barmouth North** (11.15) and **Barmouth South** (11.14)

The beach north of North Promenade is comprised of a shingle/cobbles bank that fronts the railway line. Along North Promenade and to the south of North Promenade, the sediments are mainly comprised of sand with isolated pockets of shingle/cobbles along the upper foreshore.

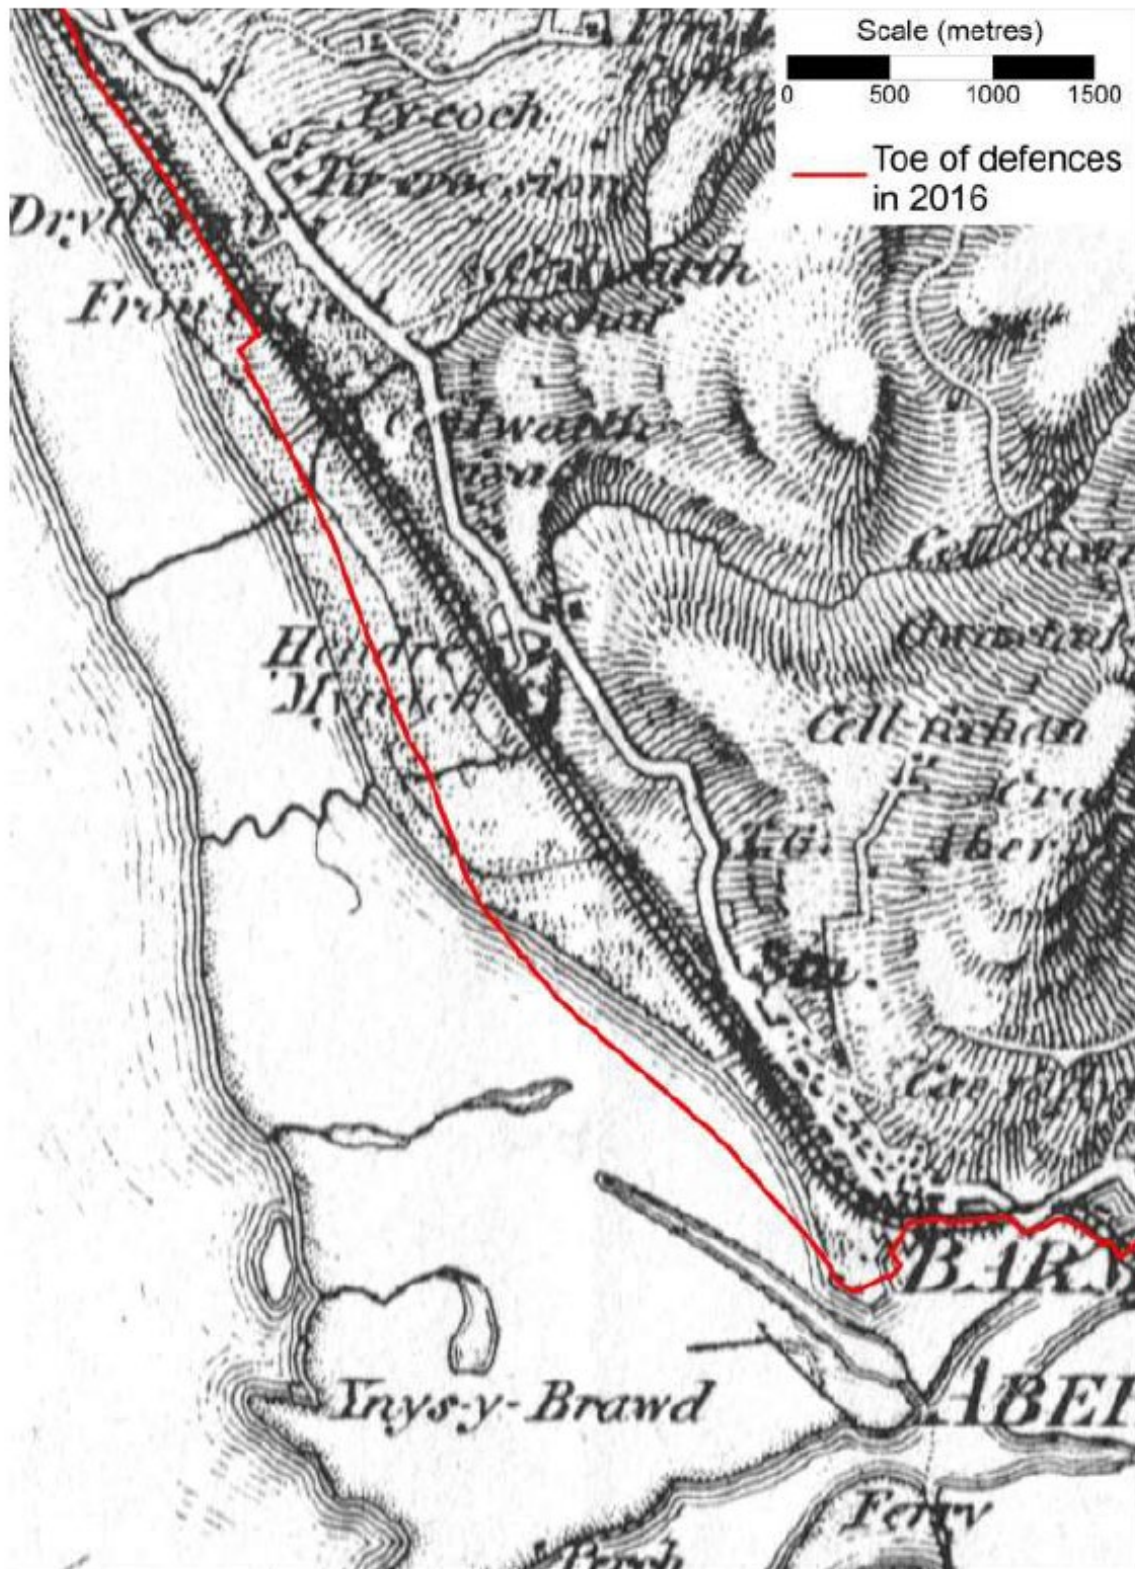
Figure 3. First edition One-Inch Ordnance Survey map, surveyed 1833-35, with the railway line added later

- A breakwater was built on Ynys y Brawd in 1797 providing more shelter for the harbour which was completed in 1802.
- 1800's:
  - The First Edition One-Inch map (Figure 3) shows a relatively wide beach which decreases in width towards North Promenade. This map should be considered with caution as it is largely schematic.

At the southern end of North Promenade around Profile 7 and Profile 8, hard outcrops are situated just off the frontage. These outcrops may provide some protection to the frontage, by helping to attract and maintain sediment in the lee. It is noted that the promenade protrudes seawards at this location which is an artefact of the historical natural shoreline (Figure 3), which also extended seawards at this location, possibly due to the presence of the shoals.

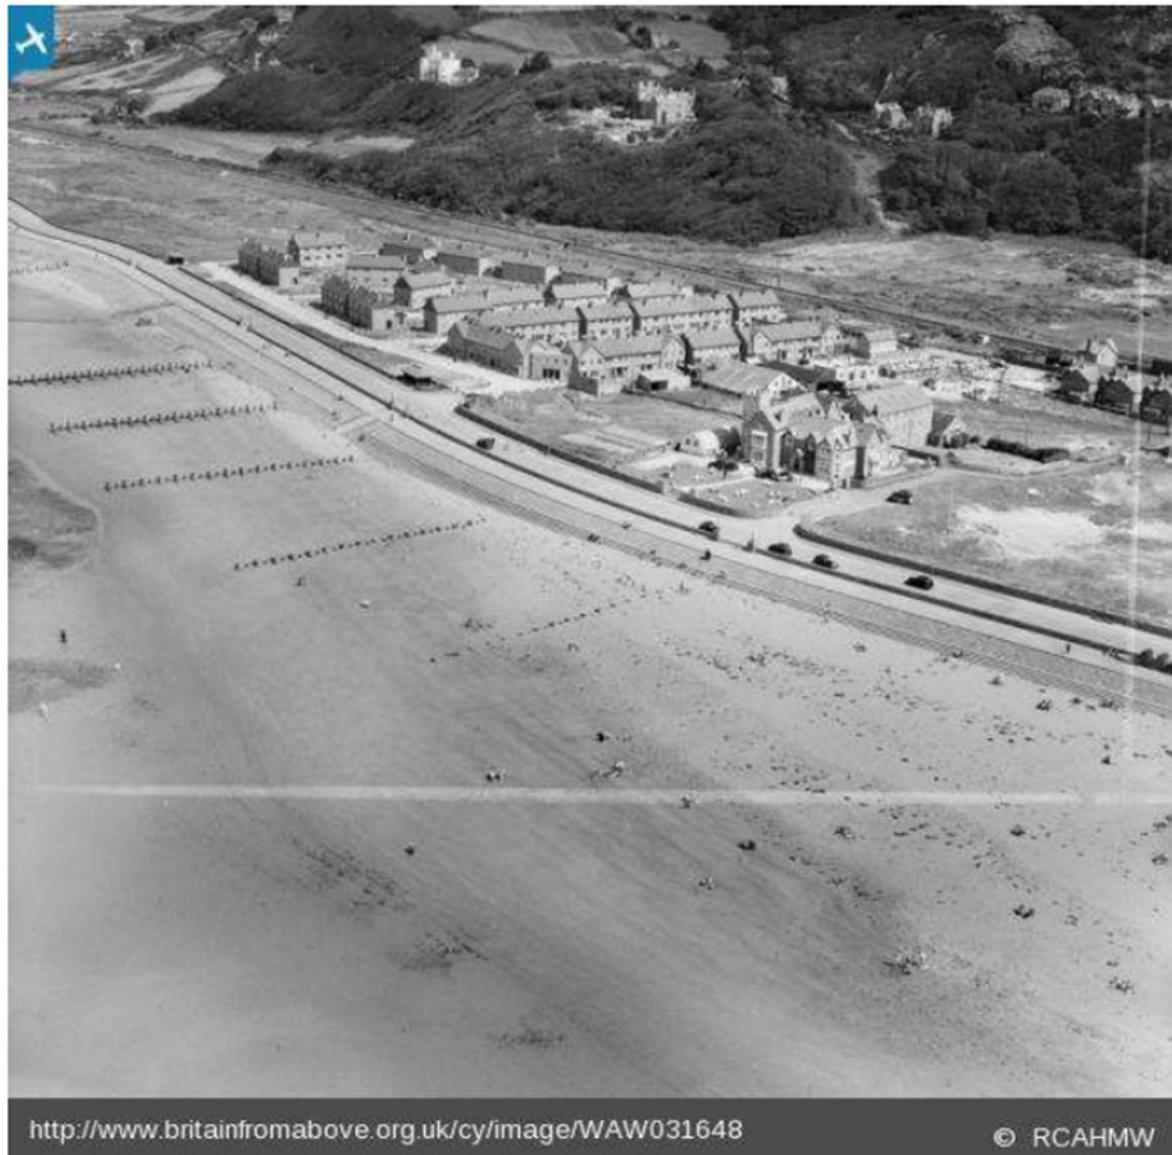
Figure 4. Oblique aerial photography, taken 1950

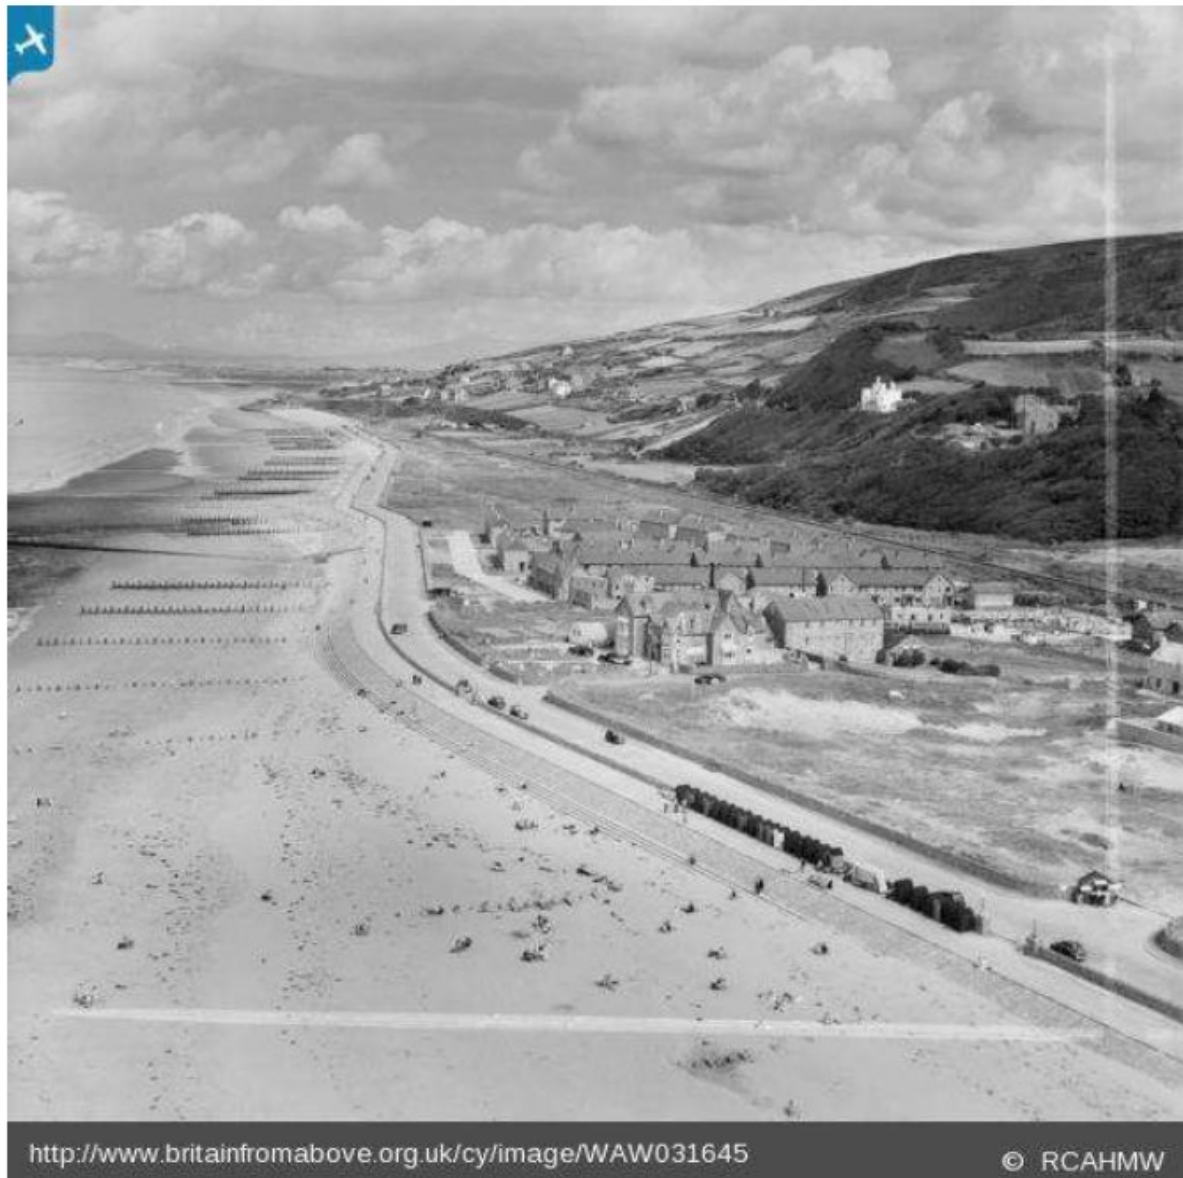
Figure 5. Oblique aerial photography, taken 1950

- 1940-1950 the northern (Bar Bach) channel was not continuous to the sea at the level of mean low water (MLW), although a shallower channel above this level apparently extended almost parallel to the shore as far as the drainage pipe opposite the Recreation Ground. The shoaling of the Bar Bach Channel in the later 19th and early 20th centuries may have been triggered by the construction of the Mawddach railway viaduct in 1866-67. Shortly after the 1950's concerns were expressed about falling beach levels in front of a section of vertical sea wall at the northern end, and in 1956 the wall between groynes 25 (middle of North Promenade) and 34 (north of the caravan site) was provided with strengthened toe protection using sheet piling encased in concrete. Aerial photography taken in 1954 that show the groynes at North Promenade are presented in Figure 4 and Figure 5. A schematization of the sheet piling, which also shows indicative beach levels is shown in Figure 6.

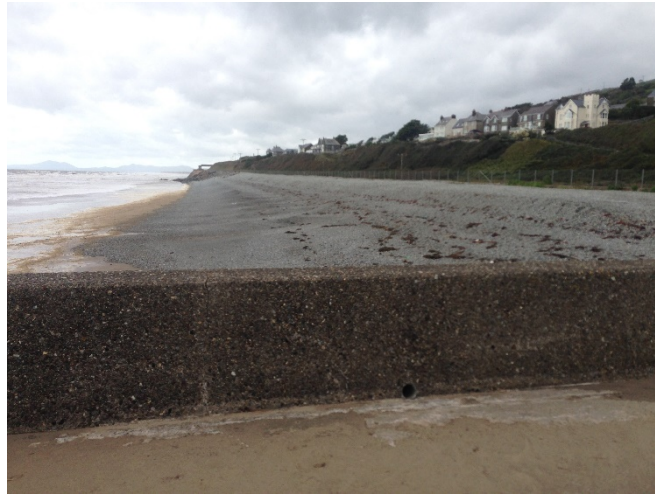
**Figure 9. Shingle/cobbles to the north of North Promenade**

North of North Promenade a shingle/cobble bank serves as the primary defence in front of the railway line (Figure 9).

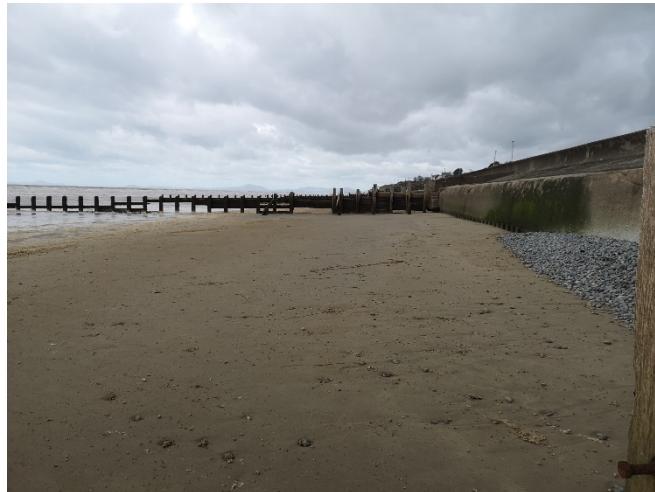
**Figure 10. Photo taken looking in a northerly direction in front of North Promenade defences showing a sandy beach with a small shingle pocket**

Along North Promenade the foreshore is primarily comprised of sand with isolated pockets of shingle/cobbles (Figure 10). This continues along the northern section of South Promenade, where shingle/cobbles are constrained within the groyne bays. Along the southern section of South Promenade, an extensive sand beach exists, on which an extensive dune system has formed (Figure 11).

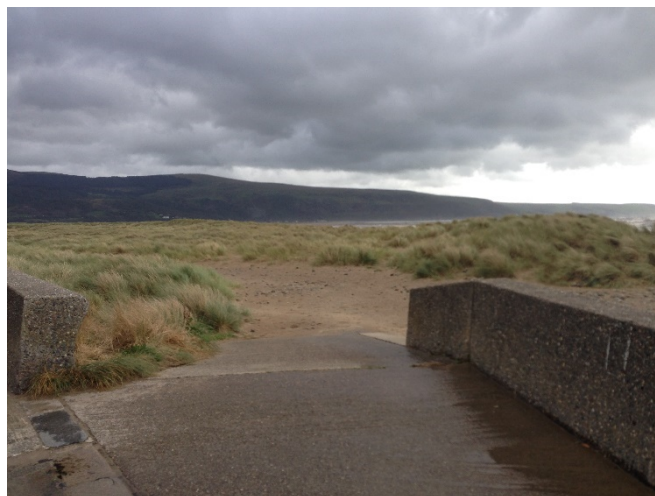
**Figure 11. Photo taken looking in a southerly direction in front of South Barmouth defences showing a sandy beach with dunes and occasional shingle clasts**

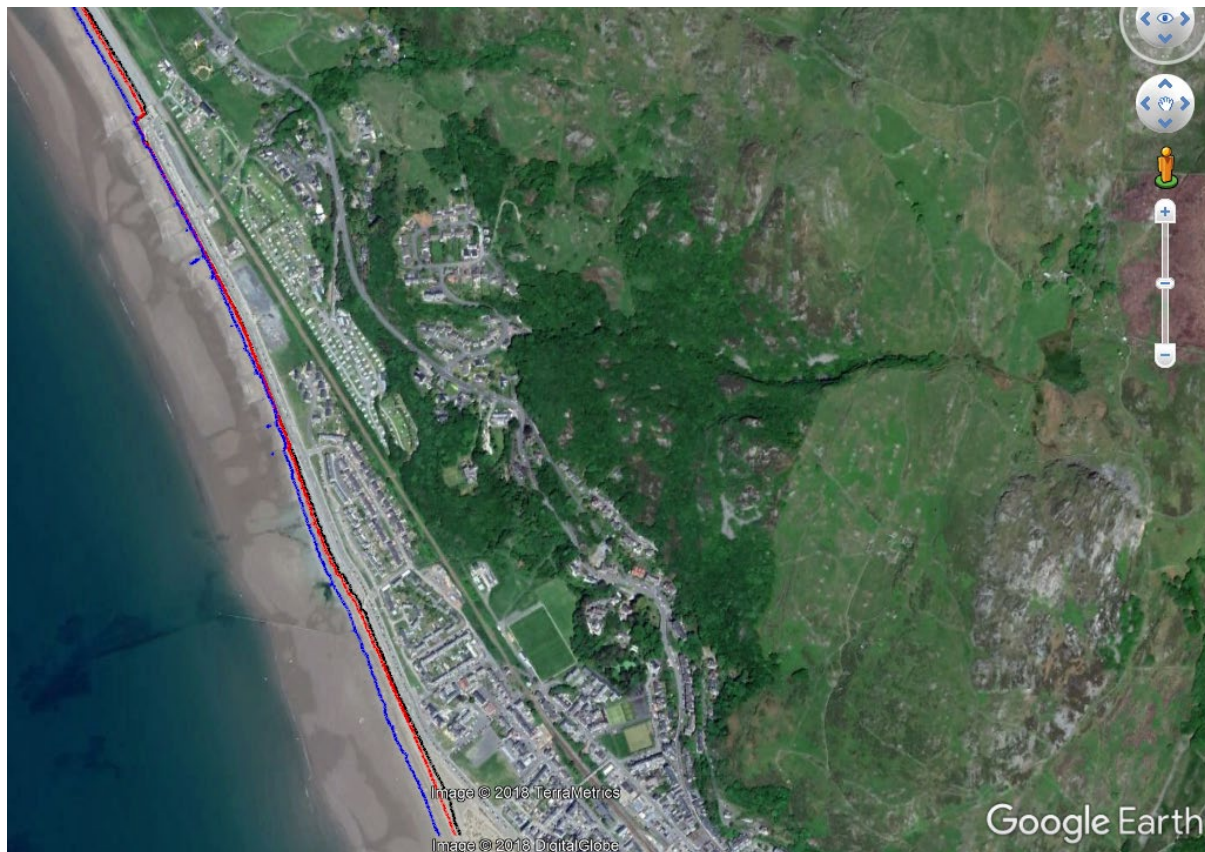
Figure 28. Aerial Image of North Promenade showing coastline for different existing tidal levels (MHWN = 1.3 mODN in blue, MHWS = 2.6 mODN in red, HAT 3.3 mODN in black), based on the composite DSM

This is demonstrated in Figure 28, where the location of the MHWN, MHWS and HAT water levels are overlaid on the aerial image of the frontage based on the bed levels in the composite DSM.

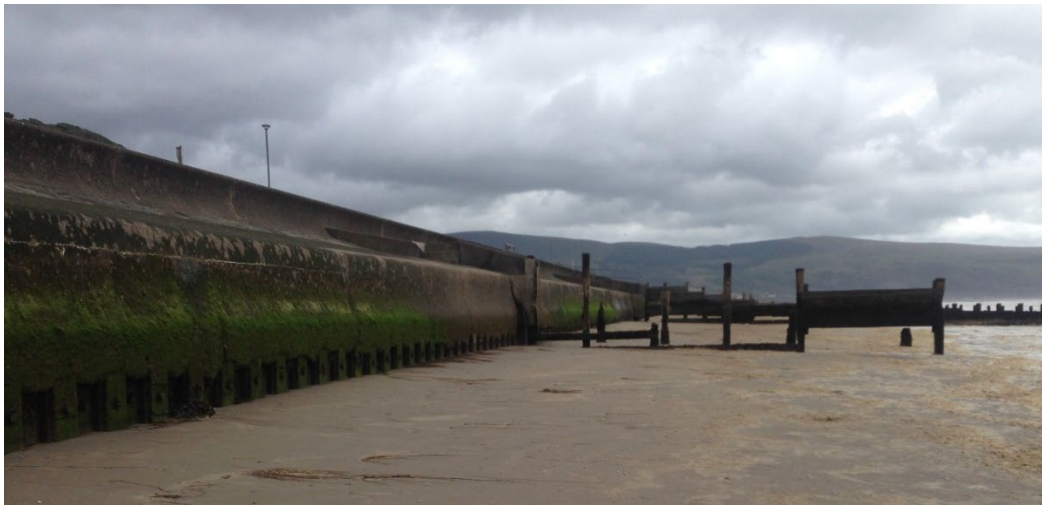
**Figure 35.** Defence of North Barmouth showing wave return wall, exposed sheet piling and groynes missing timber planks

- Defences vary along the frontage but generally consists of a vertical sheet piled sea wall, a concrete platform, stone blockwork revetment, and precast concrete wave recurve wall units Figure 35;
- Older secondary and tertiary setback walls (on either side of Marine Parade coastal road), constructed *circa* 1933, thought to help to protect against coastal flooding caused by wave overtopping;
- The sea wall is generally in good condition where undermining of the sea wall does not occur;
- At the northern end of the promenade sheet piles are exposed and corrosion of the sheet piling was occurring; and
- Low beach levels and wave action is causing undermining of concrete access steps and the sea wall.

- Timber groynes are in place in front of the promenade to control the longshore movement of sediment, the groynes condition varies from north to south;
- The groynes' in the north have limited functionality in trapping sediments due to missing timber planks and are almost completely exposed; and
- The groynes in the south are almost completely covered in sediment and are in good condition. In-between each of the groynes there are small pocket of sand-shingle beaches which become sandier in a southerly direction.

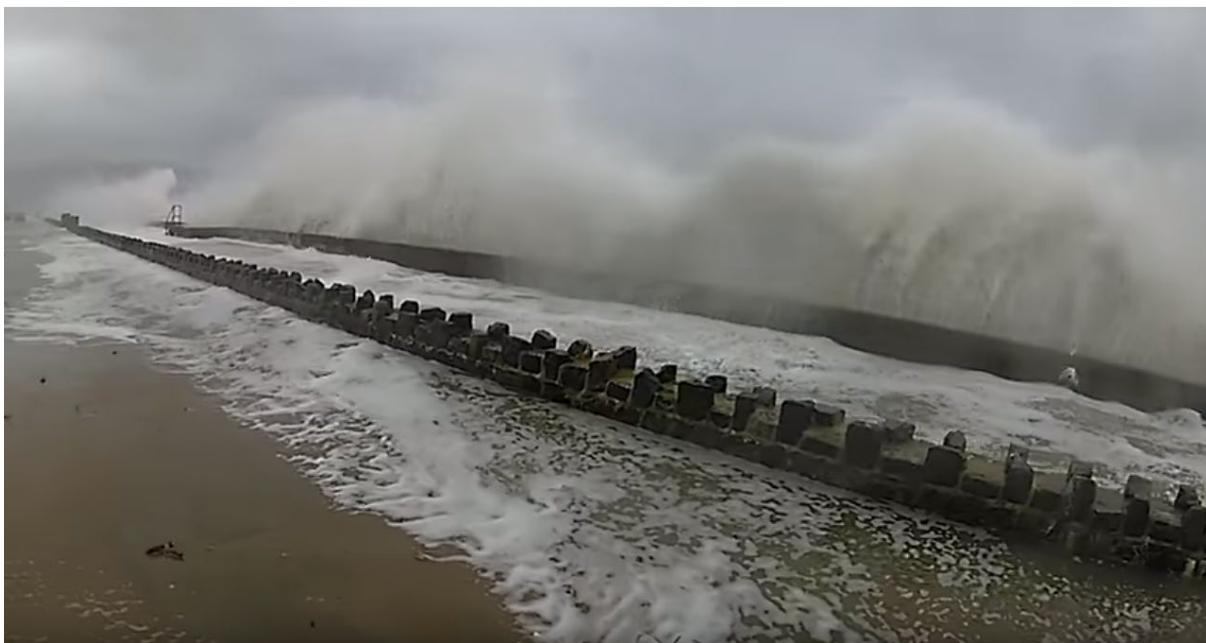
**Figure 36.** Wave overtopping at North Barmouth during Storm Brian (21 October 2017)

Recent winter storms have highlighted that wave overtopping can be significant along North Promenade. Some notable events are 1 February 2014, 26 December 2015 and 21 October 2017. These wave overtopping events have resulted in flooding of properties and road closures along North Promenade. Figure 36 shows a still image of the primary defences of North Promenade overtopping during Storm Brian (21 October 2017). Figure 37 and Figure 38 show photographs of wave overtopping at Barmouth North Promenade taken by Mike Alexander.

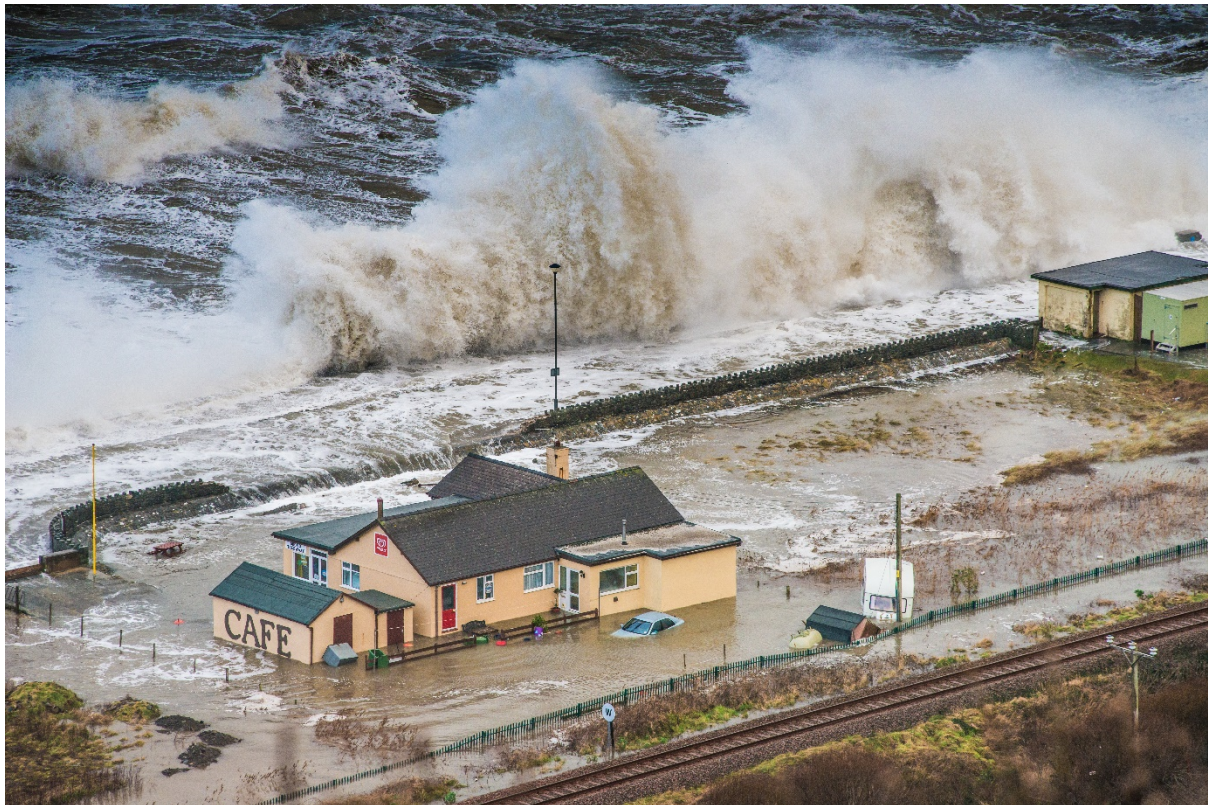
**Figure 37.** Wave overtopping near Promenade Cafe & Wine Bar on Barmouth North Promenade during February 2014 storm

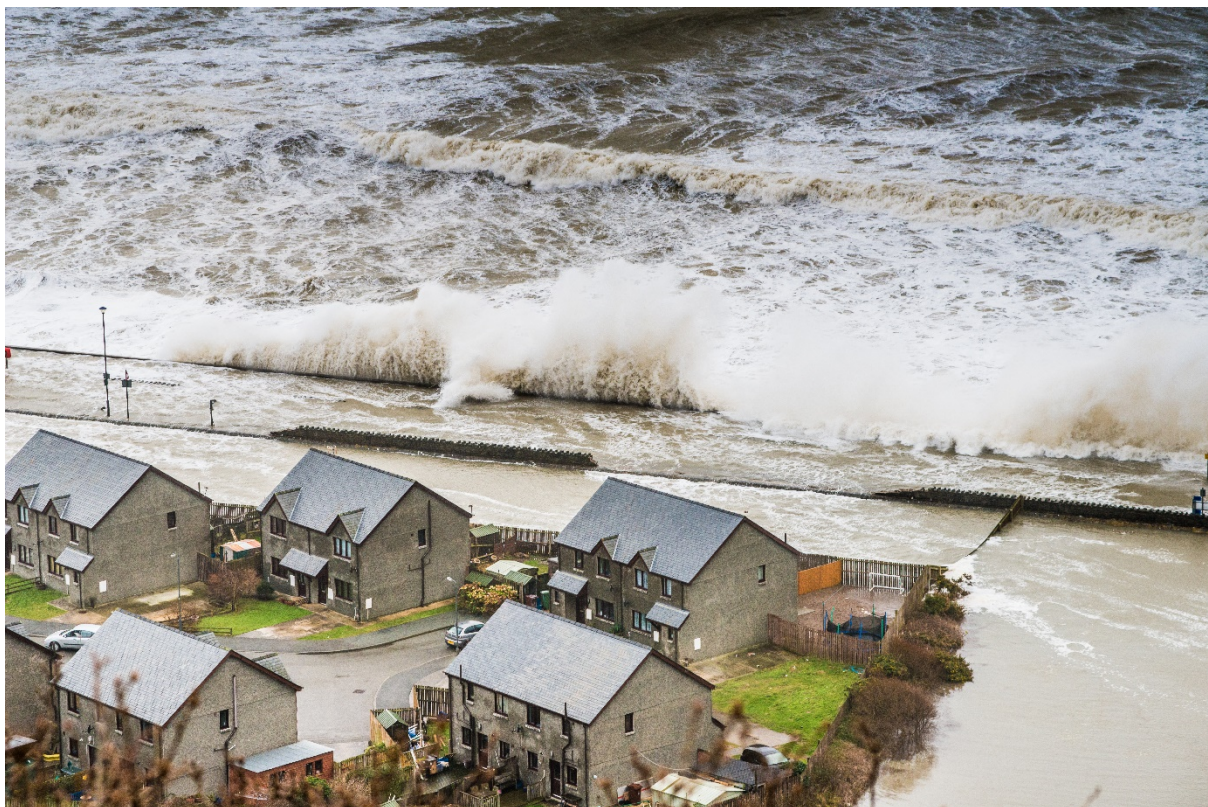
**Figure 38** Wave overtopping near Heol-y-Llan during February 2014 storm

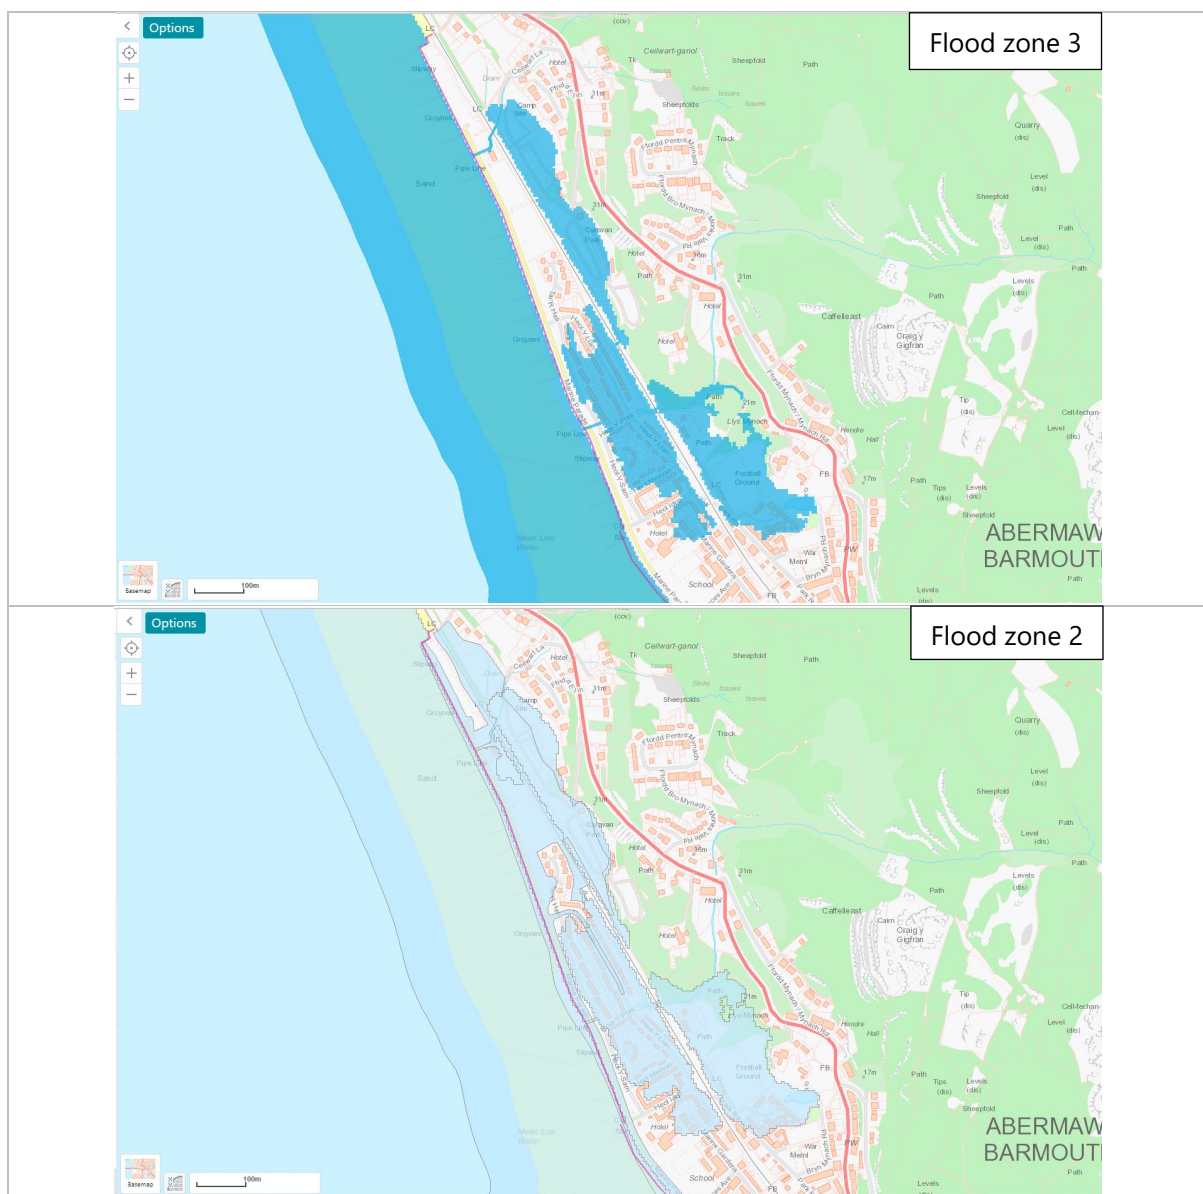
Figure 39. Natural Resources Wales (NRW) Flood Maps

This highlights that North Promenade has a greater than 0.5% chance of being flooded in any given year (e.g. it could be flooded with a return period of event of 1 in 200 years or less).

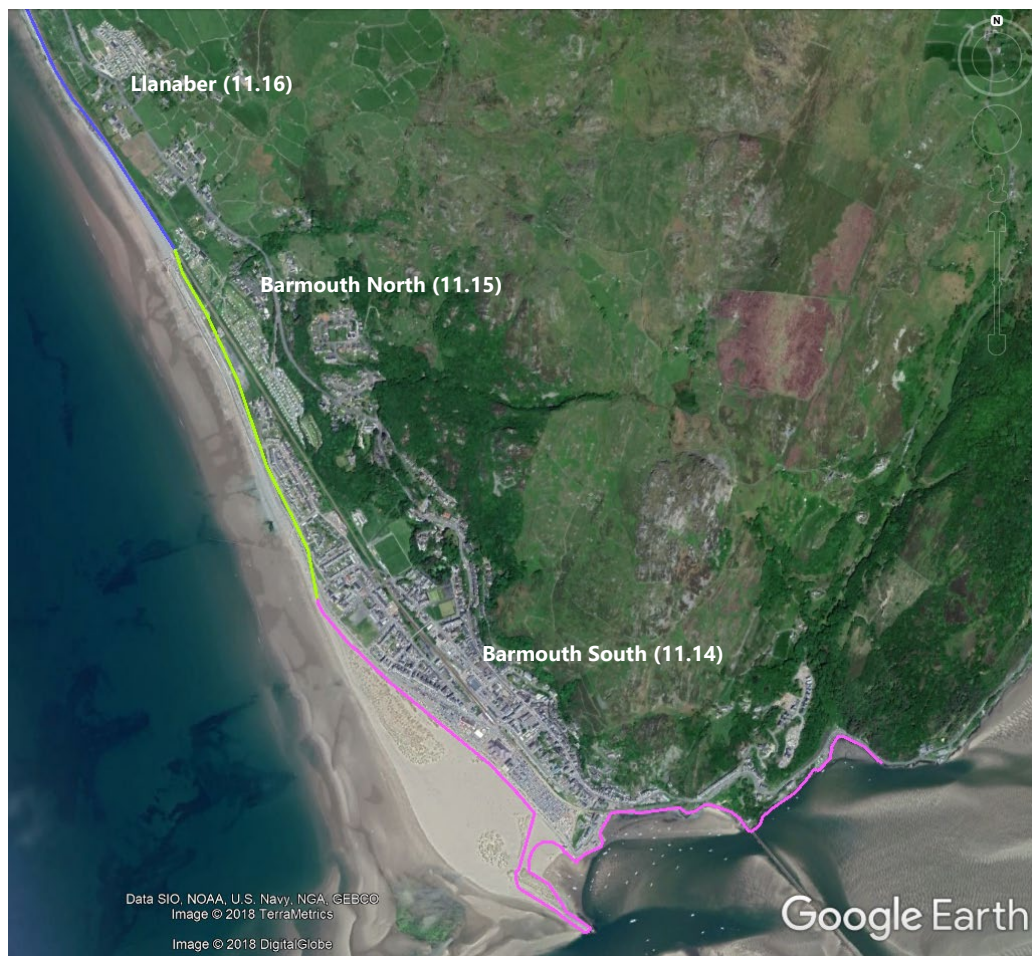
Figure 40. SMP2 policy units of Barmouth. Llanaber (11.16), Barmouth North (11.15) and Barmouth South (11.14)

North Promenade lies within Sub Cell 9, Policy Unit 11.15 of the current Shoreline Management Plan (SMP2) (Royal Haskoning, 2011). The extent of the policy unit and the adjacent policy units are shown in Figure 40.

Barmouth North, Policy Unit 11.15 lies between Barmouth South and Llanaber, policy units 11.14 and 11.16 respectively (Figure 40). The SMP2 notes that an adaptive approach to management is needed and although Barmouth North, Barmouth South and Llanaber are classed as three separate units, the policies need to be progressed as one. The three units have consistent policies until 2025 (HTL) but policies for Llanaber and Barmouth South remain as HTL in the medium and long term and therefore consideration of how a MR could be implemented in this context is required.
