**Barmouth North Promenade  
Outline Business Case**

Geotechnical desk study

Issue | 30 October 2018

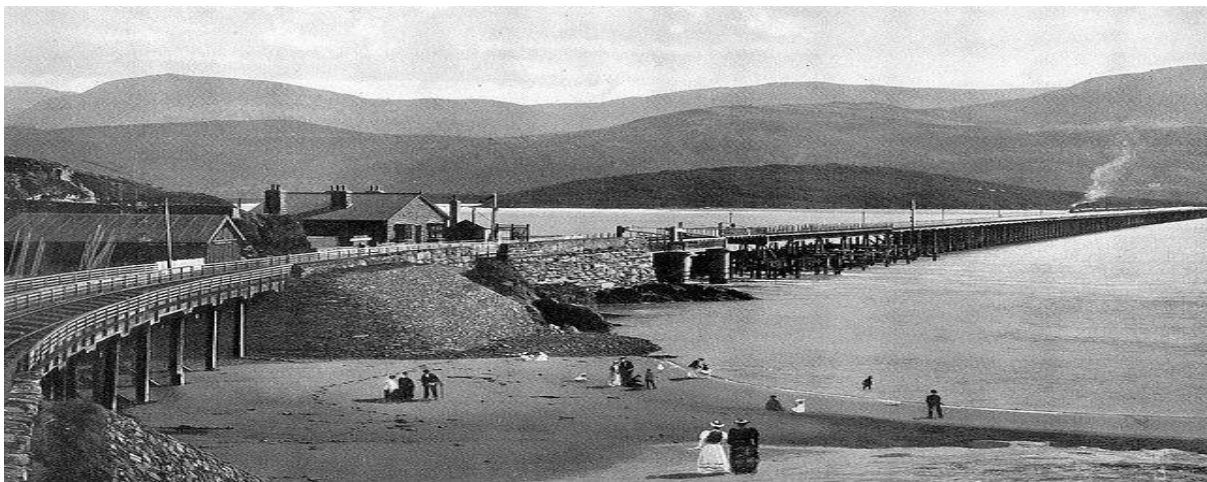
**Photo 2. The arrival of the Aberystwyth and Welsh Coast Railway in 1867.**

*“Like many other small seaside towns along the West Wales coastline, Barmouth was, up until the mid 1860’s, a commercially operational and successful port (see Photo 1), however the “face” of Barmouth changed dramatically with the arrival of the railway in 1867 (see Photo 2) and as a consequence the import and export trade together with the ship building trade steadily declined.*

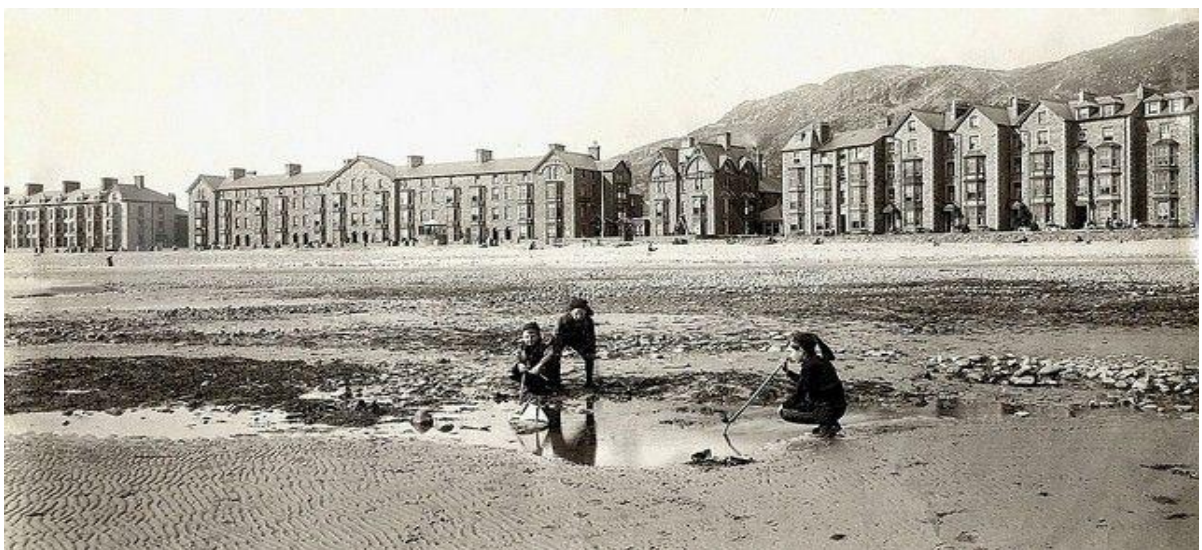
**Photo 3. The "promenade" from the beach Circa 1880.**

*Somewhat differently to the seaside towns of Tywyn to the south and Pwllheli to the north it appears that the Barmouth frontage was never adorned with the grandeur of a Victorian "style" promenade. Although it appears that an informal frontage consisting of a variety of masonry and timber structures was built between the beach and the new seaside hotels and guest houses during the early part of this era (see Photo 3).*

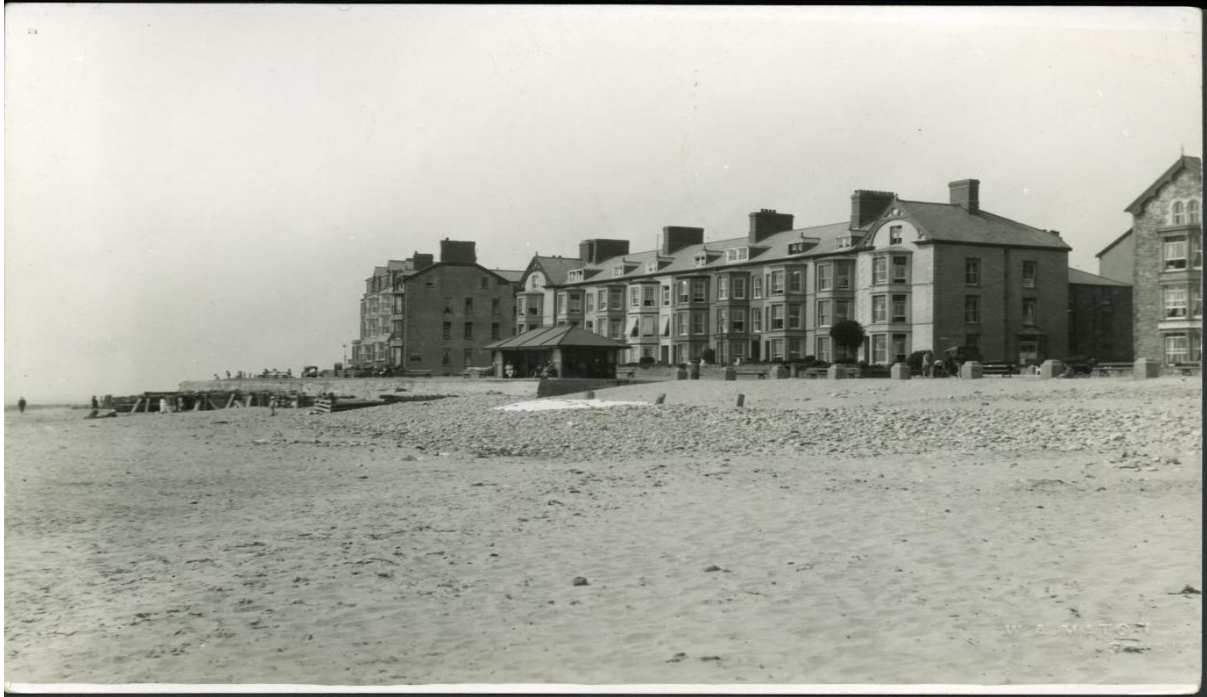
**Photo 4. Defences extending towards the northern end of Marine Parade.**

- 2.2.7 Not until the late 1920's did Barmouth Urban District Council, commission works to undertake construction of a new sea defence structure which generally is the predecessor of the existing defences. Storms during the late 1920's and early 1930's had rendered the existing defences almost to the point of dereliction, in particular the area which was developed most shoreward at the time at the Min y Mor Hotel. At this time no formal defences existed either to the north of this location or immediately south until the northern end of Marine Parade (see photos 4 and 5 below).

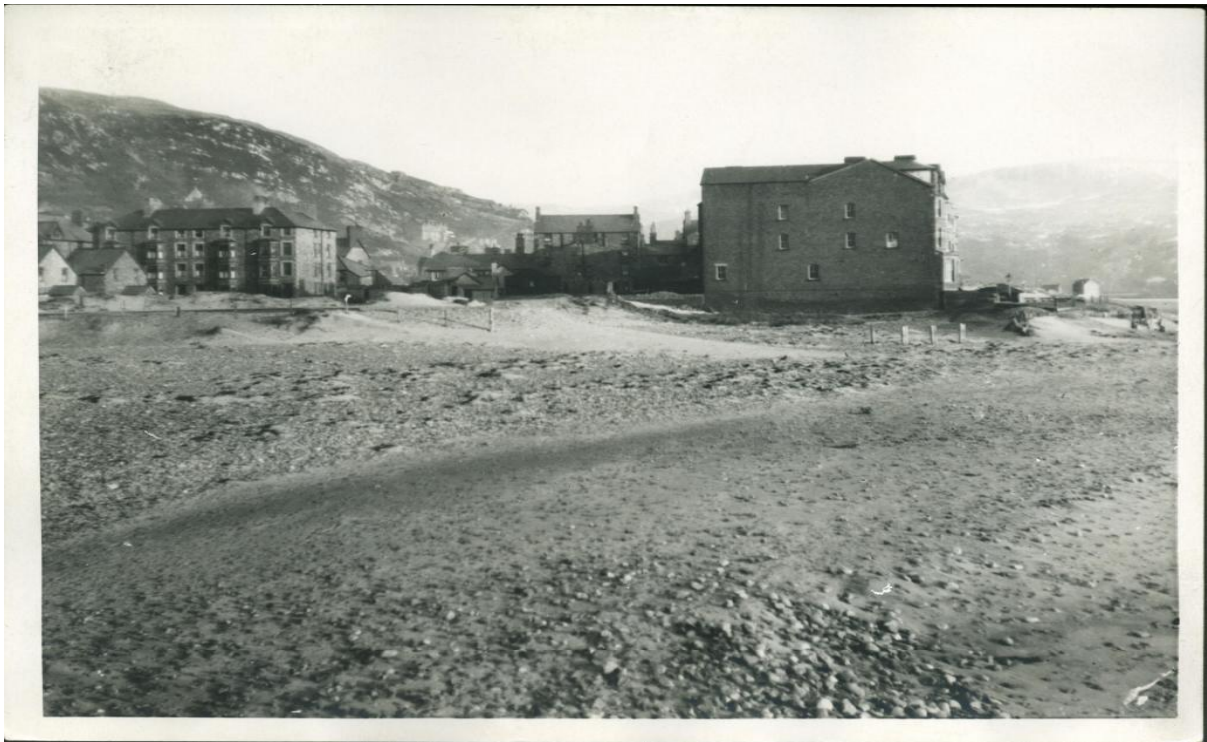
**Photo 5. Showing northernmost defences to Marine Parade.**
