# GEOPHYSICAL SURVEY REPORT

**Geophysical survey to characterise the conditions  
of North Promenade, Barmouth**

Job reference: 7328

Date: February 2021

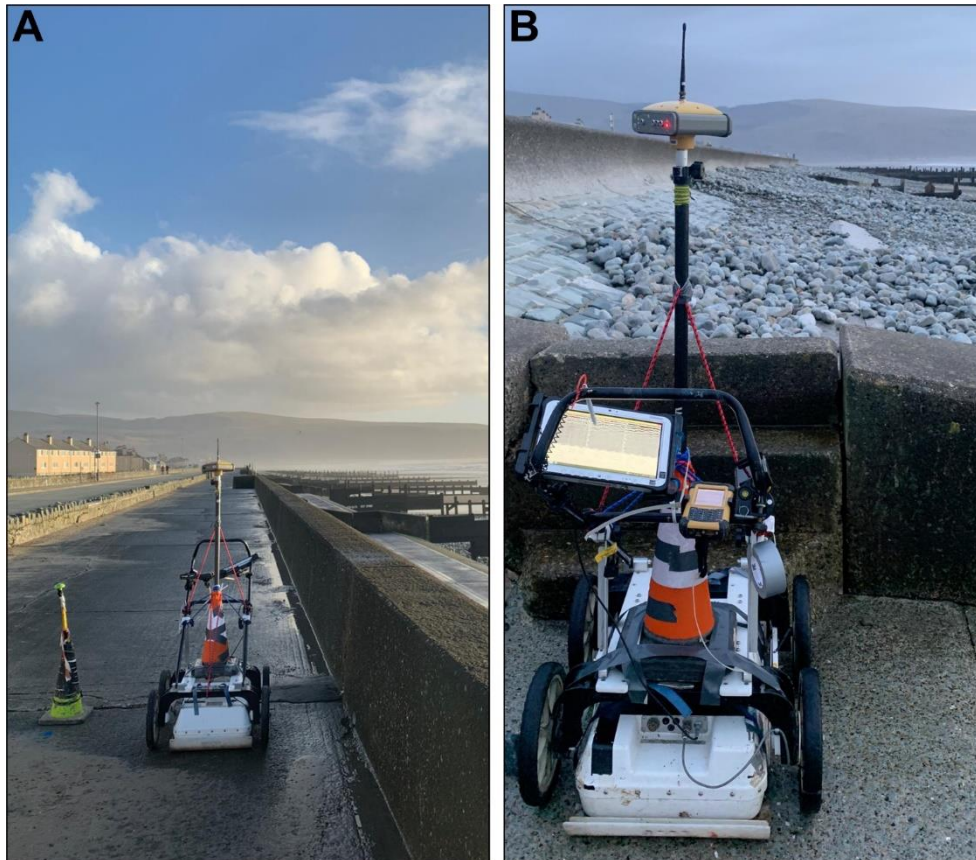
survey lines covered all accessible areas within the area specified by the Client. However, GPR Line 2 became inaccessible after a chainage of ~620 m (from the northernmost extent of the promenade) due to the presence of beach materials (Plate 2).

**Plate 2:** Data acquisition on-site. **A)** Utsi TriVue GPR system during data collection along the footpath. **B)** GPR Line 2 became inaccessible after a chainage of ~620 m (from northernmost extent of the promenade).

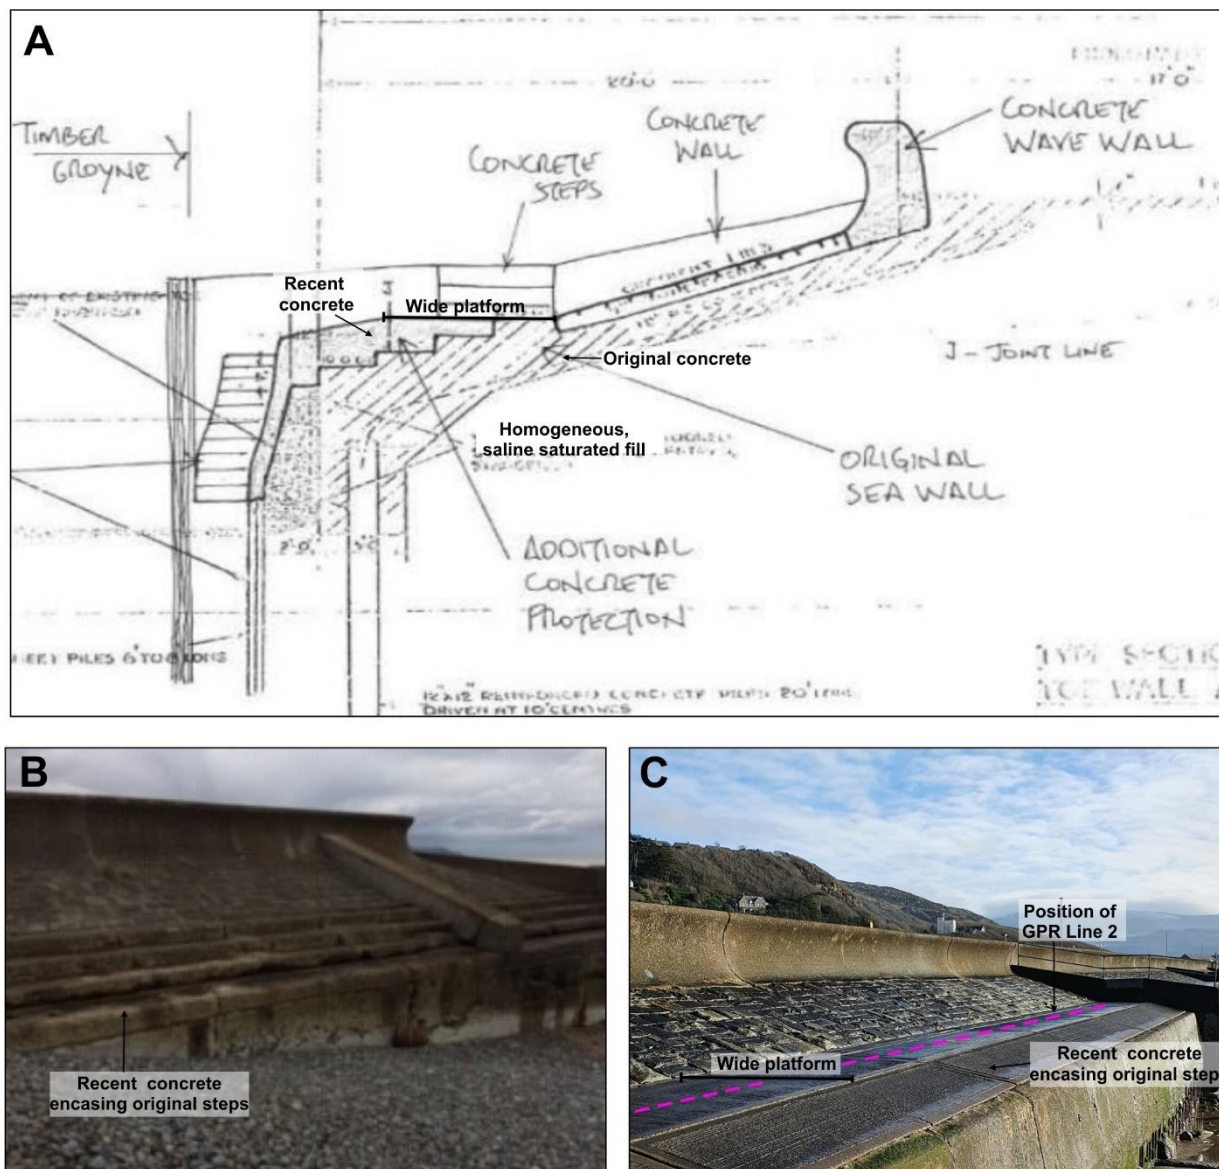
**Plate 7. A)** Historical drawing provided by the Client showing the current construction of the sea defence. **B)** Historical photo provided by the Client showing the sea wall prior to more recent refurbishment, including the encasing of the concrete steps. **C)** Photo showing the current condition of the structure as surveyed in this report.

The height between the last concrete step and the beach varies along the length of the promenade. At the northern end, it is approximately 3 m above beach level but becomes buried beneath beach material at a chainage of ~620 m (from the northern extent of the promenade). *Please note:* it was not possible to survey GPR Line 2 where it traversed along the original sea wall shown in the historical photo in Plate 5B, it is believed that this section of the wall is now buried beneath beach material.

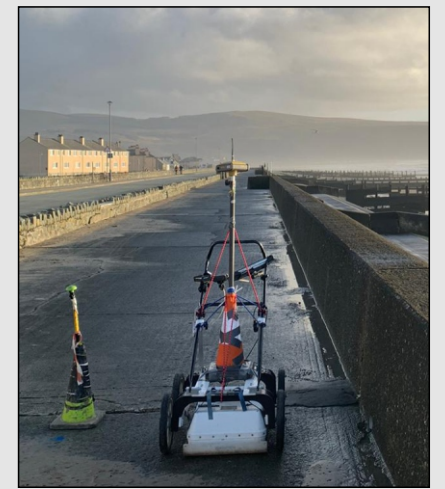
**FIGURE 2**

Radargram 203 was acquired along the footpath in the south of the survey area, where the data has a good signal penetration to 1.5 m bgl. Regularly spaced zones of increased signal penetration (shown in dark blue) relate to the presence of joints between slabs, the presence of isolated zones of high-amplitude response beneath the joints may be indicative of localised voiding associated with them, one such feature has been noted as **F2**. The locations of such features are shown on Figure 4. Laterally continuous, high amplitude reflectors are occasionally also observed (**F2a**). High amplitude reflectors are also observed away from the broader zones of increased signal penetration, e.g., **F2b**. An isolated diffraction is also observable and may be caused by a void, boulder or utility (**F2c**).

Example radargram 245 shows significant signal attenuation beneath the concrete slab. This is thought likely to be caused by increase conductivity of the fill material beneath the slabs and may reflect an increase in the clay content of the fill material (this location coincides with the presence of a historical stream) or fill material saturated by saline water.

Radargram 308 shows an example of data acquired across Marine Parade Road. The road appears to be underlain by reinforced slabs (as indicated by the numerous shallow diffraction hyperbolae) and some of the voiding-related features discussed previously are observed (**F2j and k**). It should be noted that the signal penetration increases with distance away from the

**F2c and k:** Diffraction hyperbolae potentially caused by small isolated voids in the subsurface.

**F2d, f, and h:** Zones of increased signal penetration possibly caused by more granular, aerated fill. In some areas they are coincident with high amplitude reflectors.

To better interpret the data, an intrusive investigation of all examples of the identified features is highly recommended. The acquisition of cores will allow calibration of the results of the geophysical survey, after which the interpretations within this report can be refined.
