| Project title | Barmouth North Promenade | Job number |
| Subject | Existing Coastal Defence Structures Review | |

# File Note

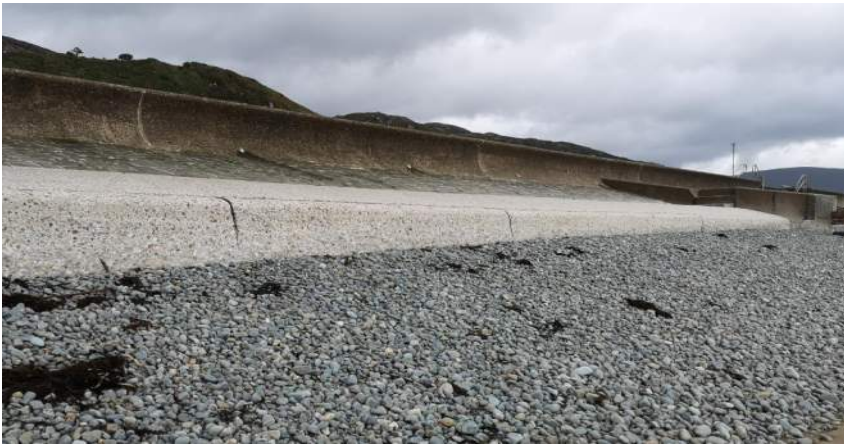
Figure 5: The concrete wave recurve wall (Arup, 2018)

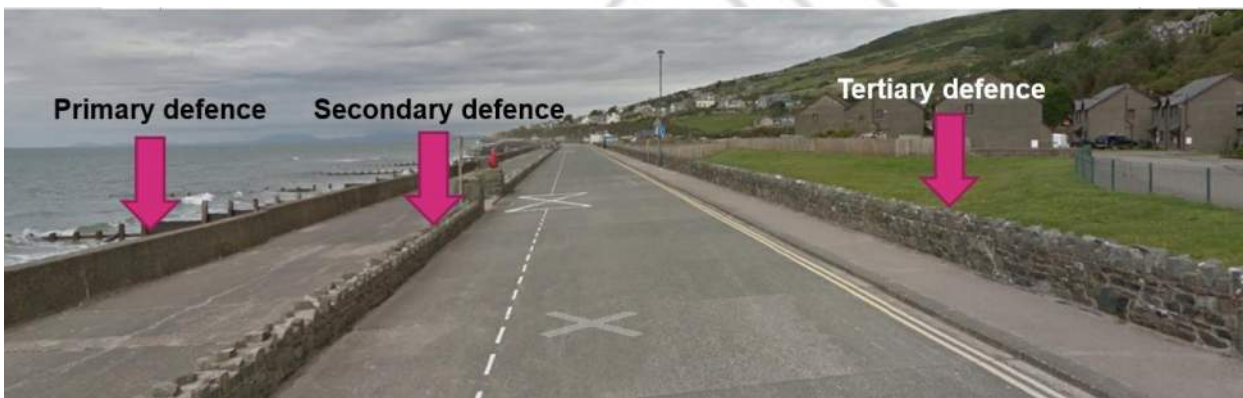
Further structures include a second and third wall, situated either side of the highway (Marine Parade), as shown in Figure 6, which help to protect against coastal flooding caused by wave overtopping. Low-lying land immediately to the north of the Heol y Llan housing estate affords protection to the associated properties through attenuation, supported by a demountable flood defence wall, as indicated in Figure 7, at the junction between Marine Parade and Heol-Y-Llan.

Figure 6: Primary, secondary and tertiary flood defences (Arup, 2018)

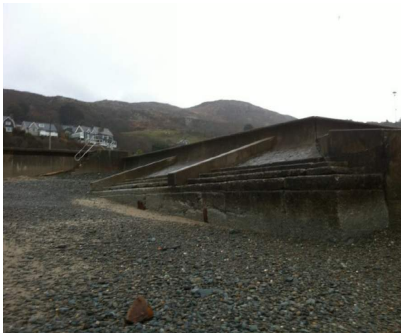
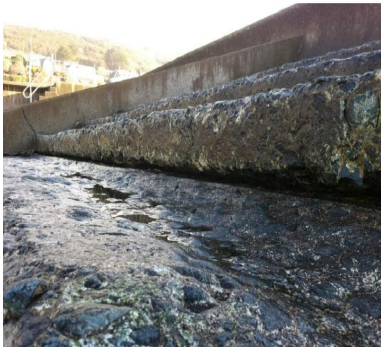
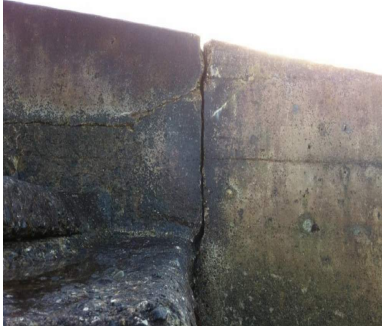
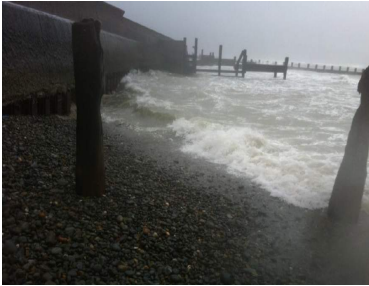
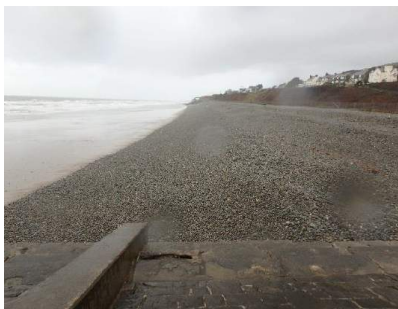
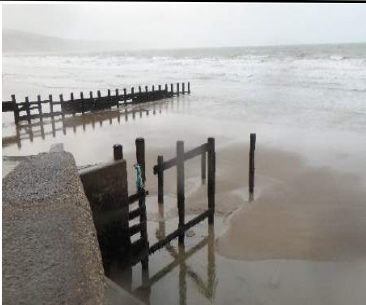
| 0000-0030m | | | | | | |
|---|---|---|---|---|---|---|
| Notes | 2014: General photo of the north facing extent of the promenade.<br>2018: A shingle embankment provides flood and erosion protection to the railway line.<br>2018 (Arup): Loss of beach material has reached the base of the structure. Risk of undermining. | 2014: Abraded cold joint at the northern extent of the promenade.<br>2018 (Arup): This seems to be in similar condition in 2018. | 2014: Vertical joint suggesting slight seaward movement at the northern side of the promenade.<br>2018 (Arup): The joint aperture does not show additional movement. | 2018 (Arup): Open joints suggest displacements, maybe due to settlement. | 2018 (Arup): Fill material loss through one of the promenade slab joints. | 2014, 2018 review and 2018 (Arup): Some groynes at the northern end of the beach are in extremely poor condition, in some cases the majority of boards are missing and the existing piles are rendered useless due to loss of section through the effect of shingle abrasion. |

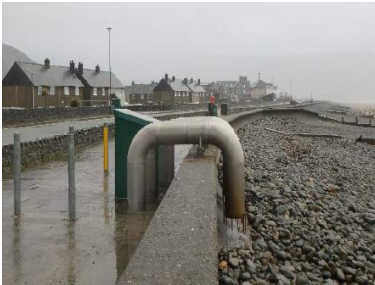
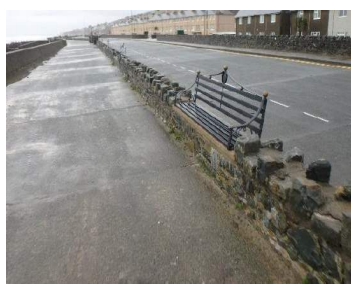
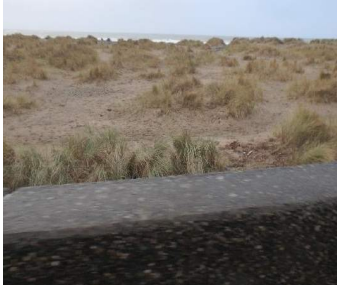
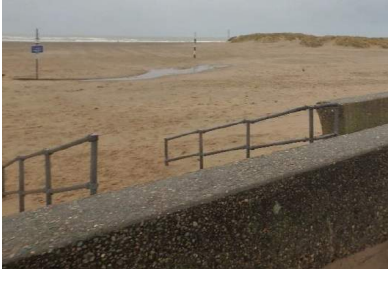
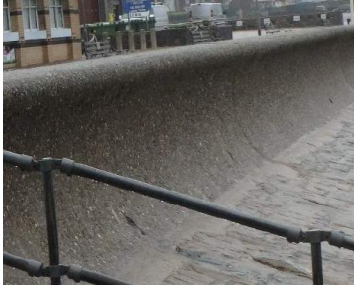
| | | 0840-1900m | | | Beyond extents of study | |
|---|---|---|---|---|---|---|
| Notes | 2014: During storm events flood waters were actively pumped from the road's drainage system over the sea defences<br>2018 (Arup): The system is considered to be in good condition structurally, except oxidation damage on the seaward face | 2018 (Arup): Outfall point of surface waters. Flap valve considered to be in fair condition and working as expected. | 2018 & 2018 (Arup) : Secondary wall has been retrofitted with benches | 2018 & 2018 (Arup): A significant dune system has formed to the southern extents of the frontage, protecting the southern end of the promenade from wave action. | 2018 & 2018 (Arup): Concrete wave wall on the southern of the promenade is in good condition | |

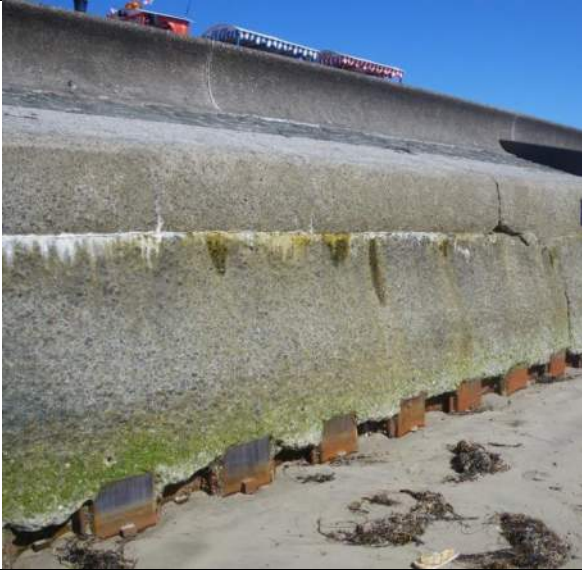
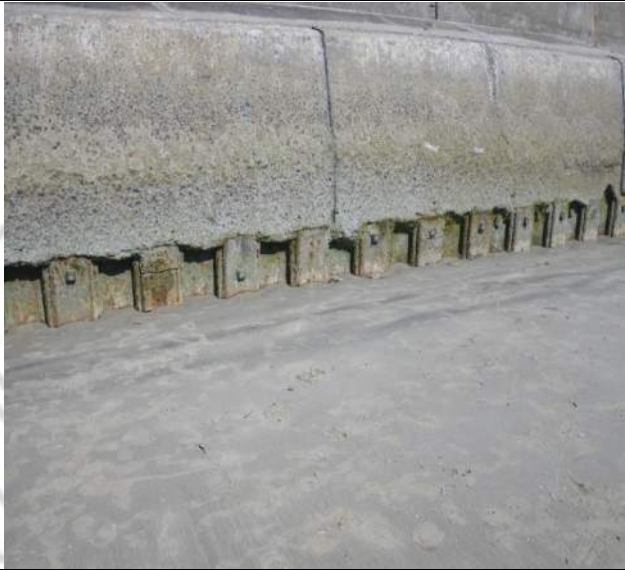
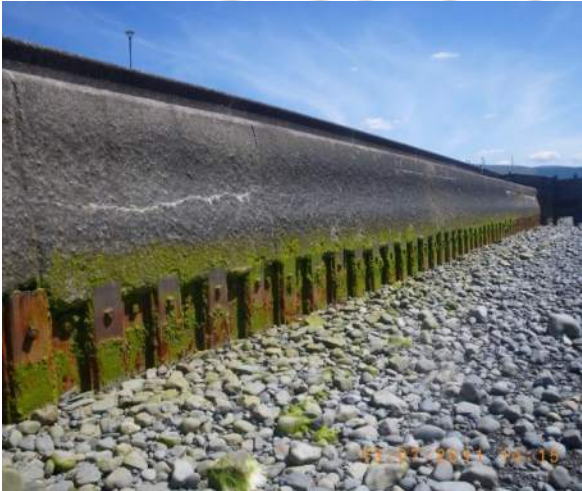
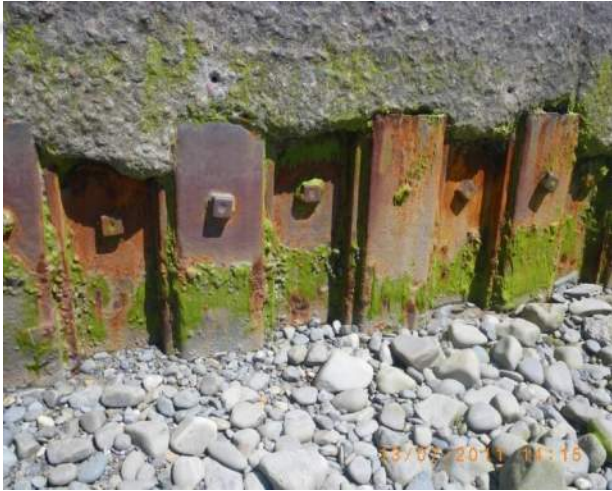
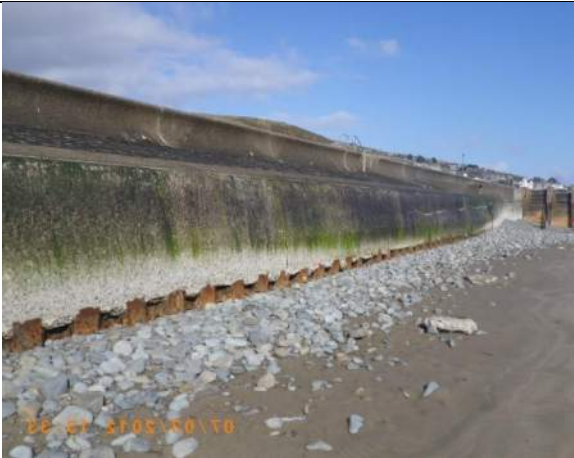
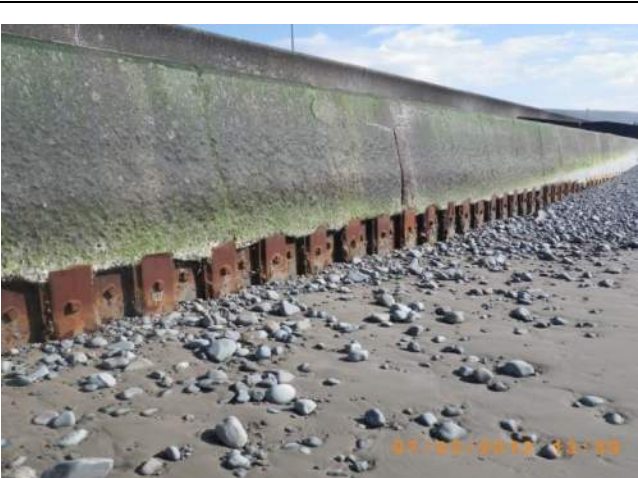
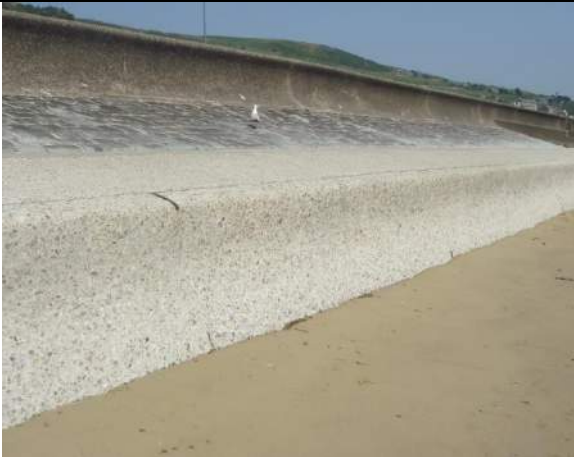
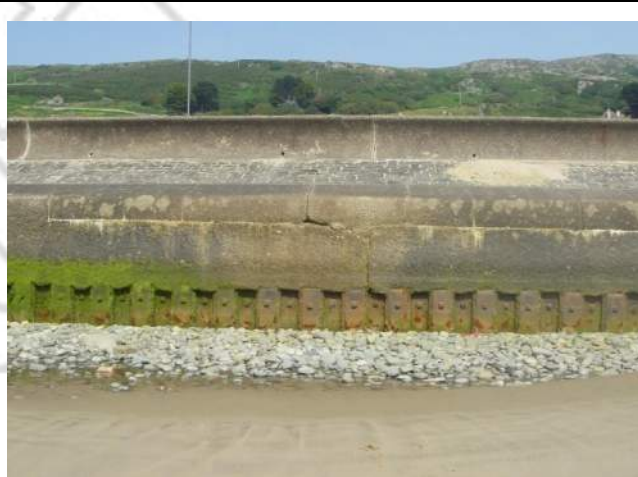
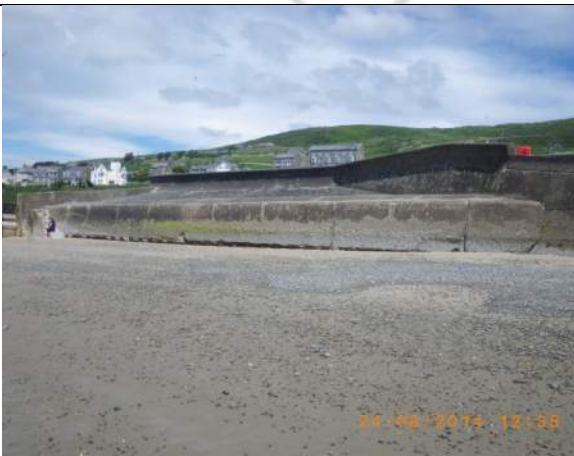
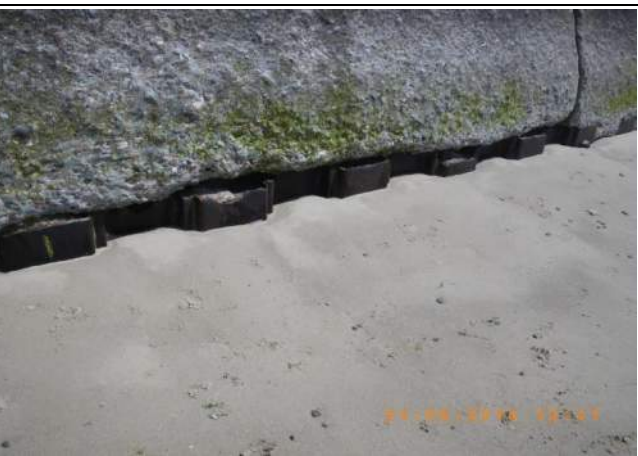
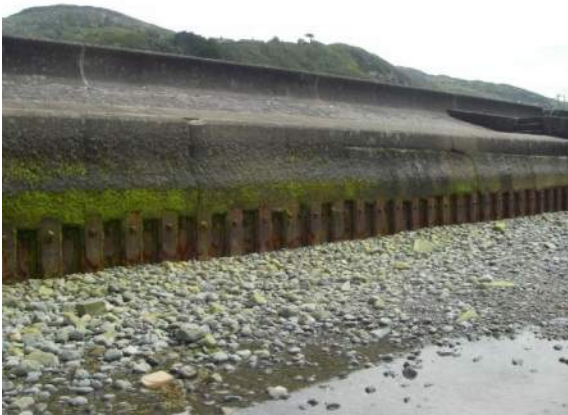
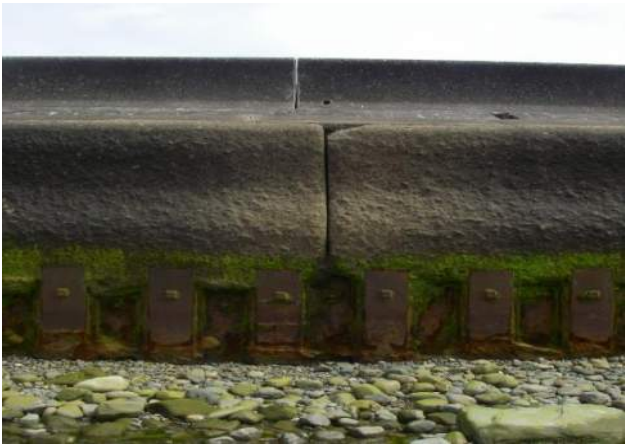
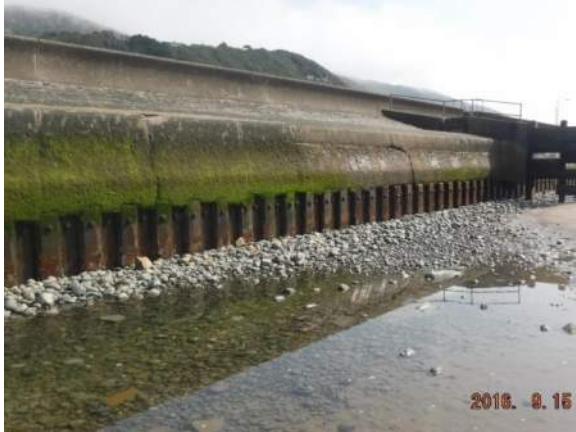
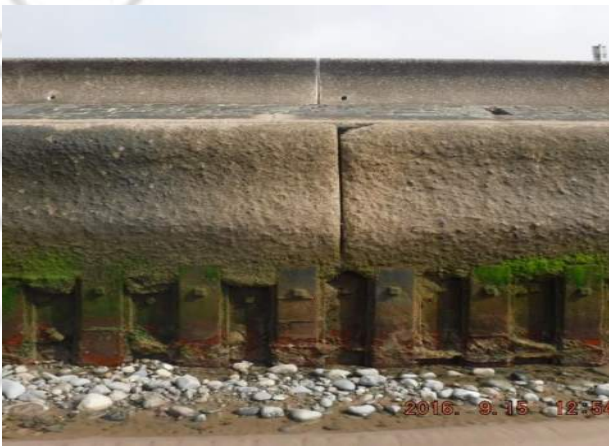
From 2010 to 2013 both sea wall and toe were assessed as in fair condition, with large cracks noted in 2016. Since 2014 a loss of sea wall joint sealant has been recorded. From 2015 extensive toe corrosion was recorded.

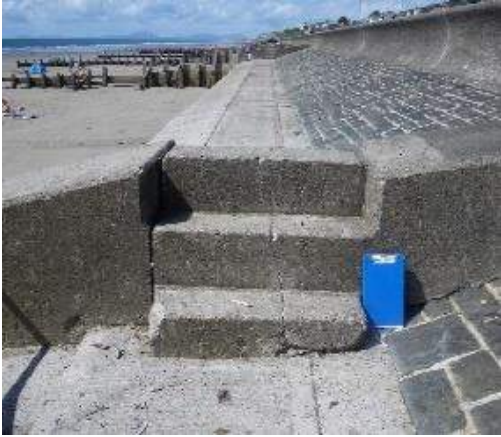
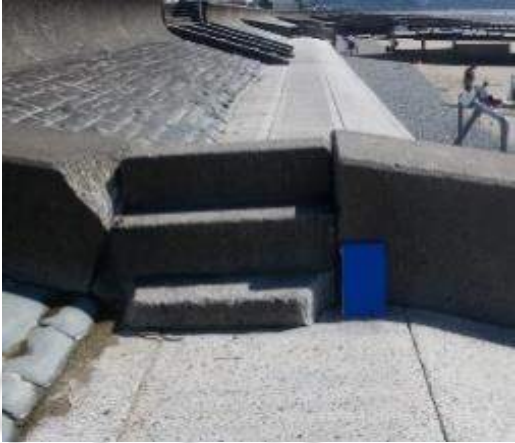
| Year | Safety elements – Steps, Apron (Groyne 16) |

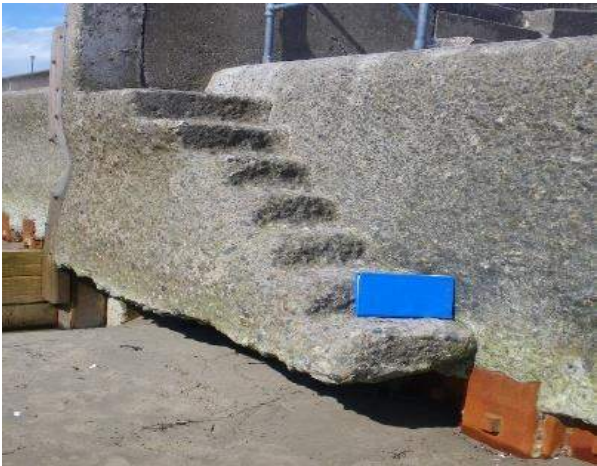
| Year | Other elements - Steps to the beach from the sea wall | |

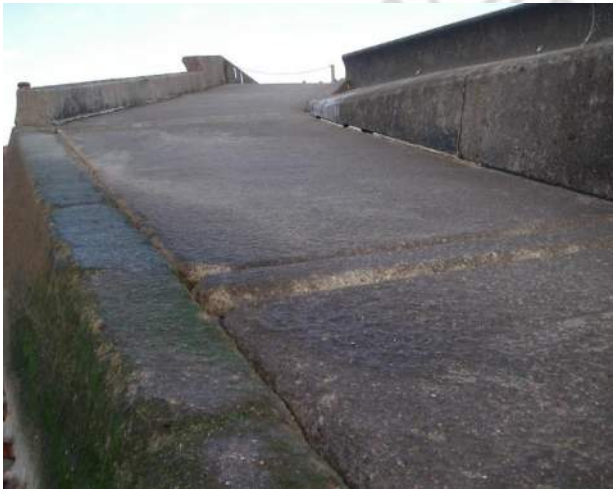
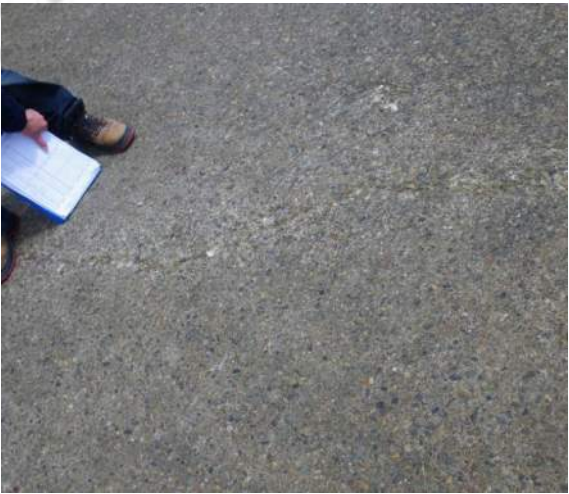
| Year | Slipway ( <i>Structural element</i> ) and Slab ( <i>Safety element</i> ) | |
|---|---|---|
| 2010 | | |

| Year | Slipway ( <i>Structural element</i> ) and Slab ( <i>Safety element</i> ) | |
